[Docket No. 96-NM-75-AD; Amendment 39-9581; AD 96-09-07]

#### Airworthiness Directives; Boeing Model 757 Series Airplanes Equipped With Moog Spoiler Actuators

96-09-07 Boeing: Amendment 39-9581.

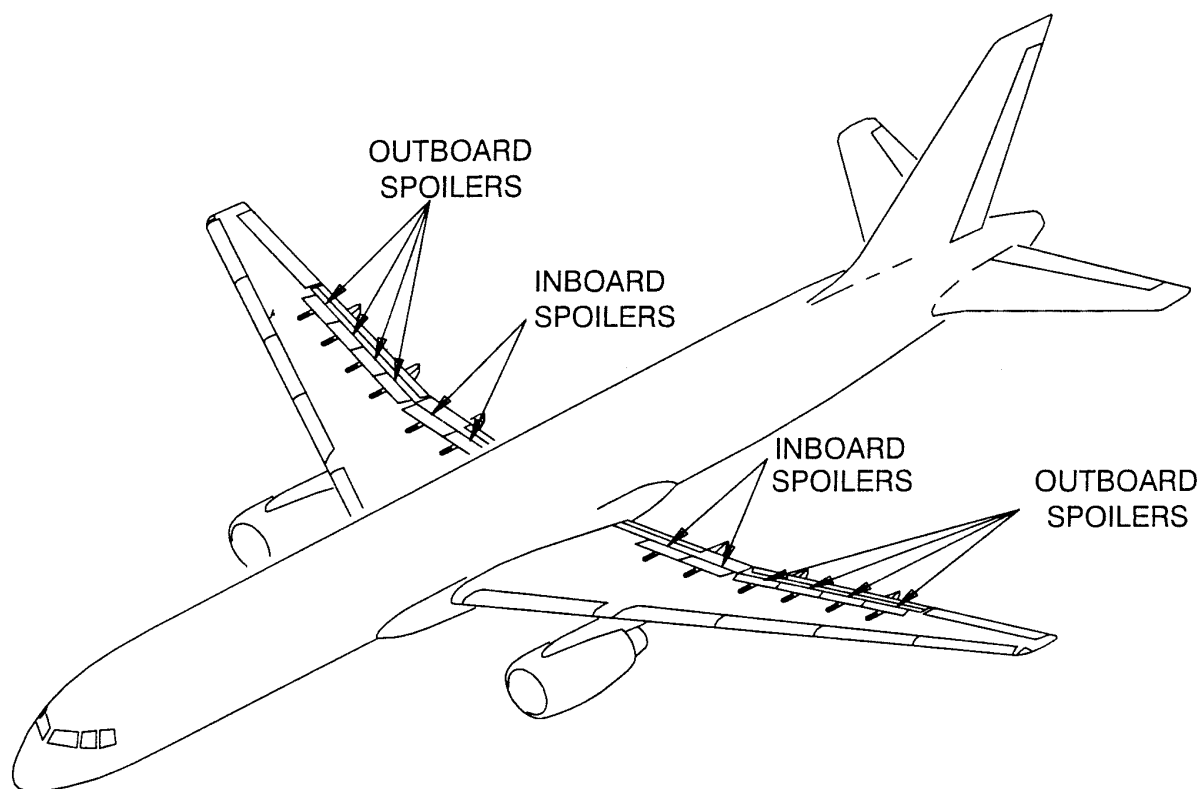
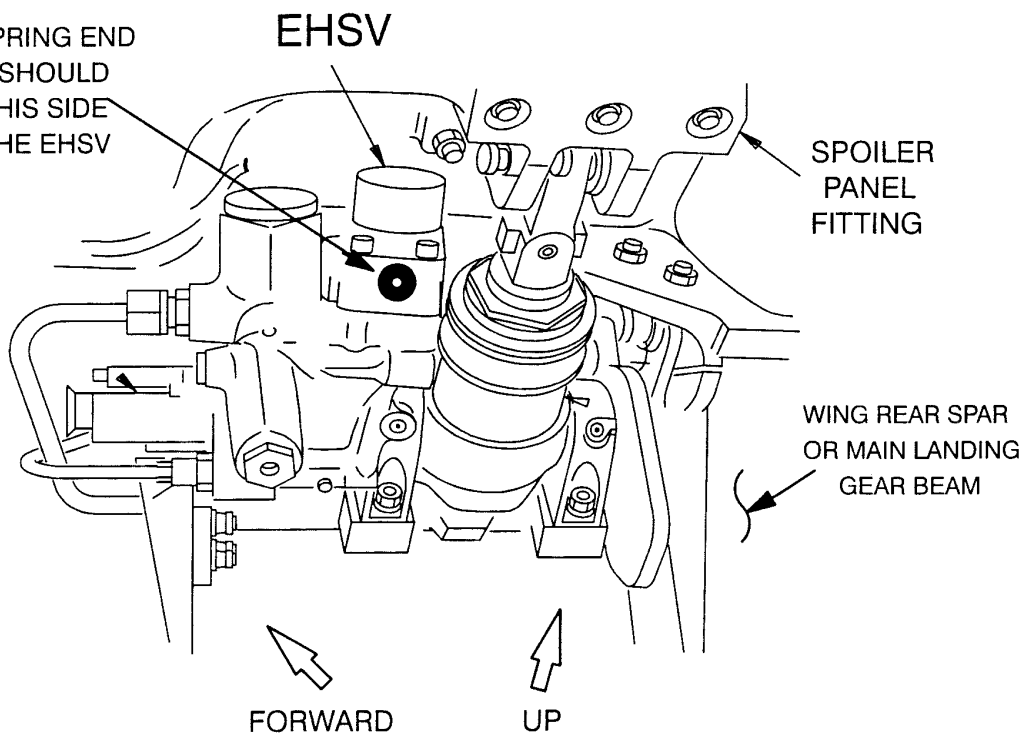
## 757 SPOILER ACTUATOR INSTALLATION

Note 2: To be correctly positioned, the second stage bias spring cap assembly should

be on the upper or forward side of the EHSV assembly. Appendix 1 of this AD provides a visual representation of the correct positioning of the EHSV assembly.

SECOND STAGE SPRING END  
CAP PROTRUSION SHOULD  
NOT EXTEND ON THIS SIDE  
(UNDERSIDE) OF THE EHSV

(1) While the airplane is on the ground, extend the flaps to 40 degrees, and visually inspect the spoiler actuator EHSV assembly to determine the location of the second stage bias spring end cap assembly.

(2) If the second stage bias spring cap assembly is on the aft or lower side of the EHSV assembly, prior to further flight, replace the EHSV, having Abex part number 72196, with a serviceable unit in accordance with the airplane maintenance manual.
