[Docket No. 99-SW-38-AD; Amendment 39-11217; AD 99-12-01]

Airworthiness Directives; Eurocopter Deutschland (Eurocopter) Model EC135 Helicopters

AD 99-12-01 Eurocopter Deutschland GmbH: Amendment 39-11217. Docket No. 99-SW-38-AD.

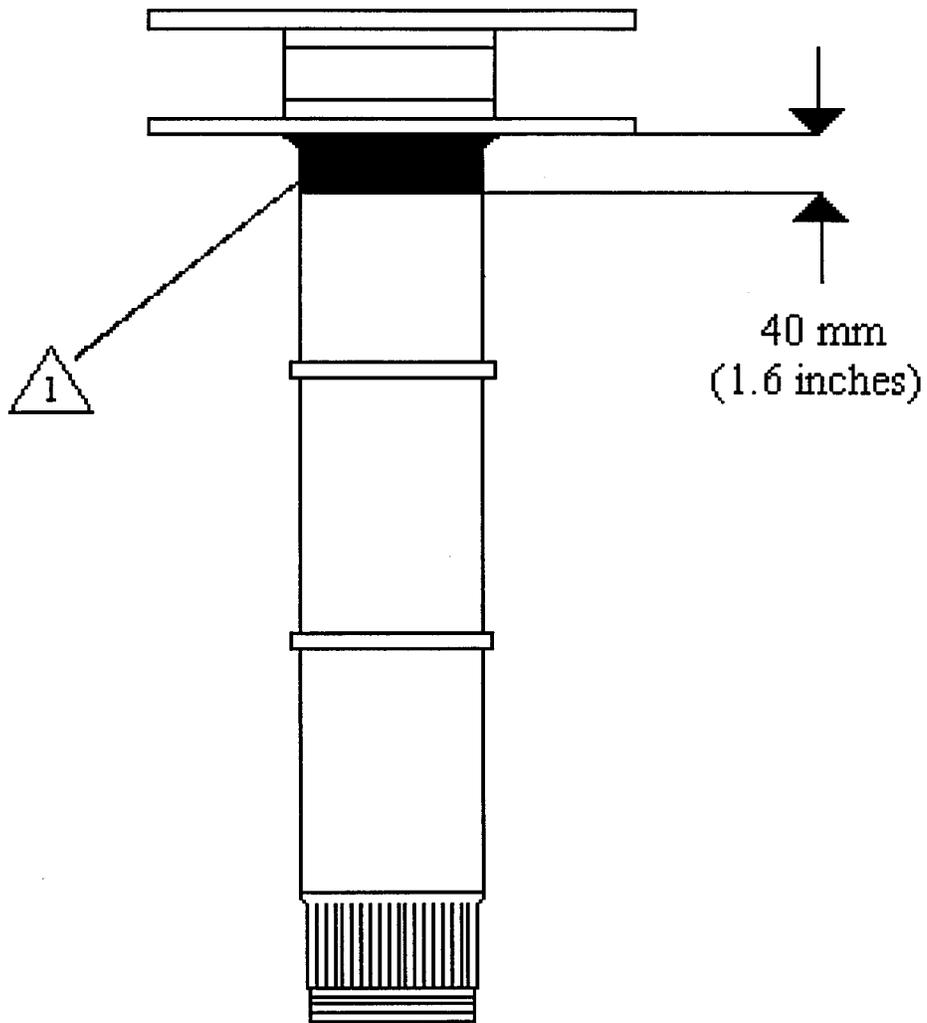
Figure 1

To detect a fatigue crack in the shaft that could lead to shaft failure and subsequent loss of control of the helicopter, accomplish the following:

△ 1 Inspect marked area in accordance with inspection procedure prescribed.

Crack Inspection on Main Rotor Hub Shaft

(a) Before further flight, and thereafter, at intervals not to exceed 15 hours time-in-service (TIS), visually inspect the shaft, P/N L623M100S 101, for any crack in the area marked in Figure 1. Clean the shaft before using a bright light source to inspect for cracks. If any crack is found, replace the shaft with an airworthy shaft before further flight.

(b) Within 10 hours TIS, conduct a one-time dye-penetrant inspection of the shaft using the MIL-STD-6866 or ASTM-E-1417 procedure in the area shown in Figure 1. If any crack is found, replace the shaft with an airworthy shaft before further flight.
