[Docket No. 99-SW-40-AD; Amendment 39-11228; AD 99-13-09]

#### **Airworthiness Directives; MD Helicopters, Inc (MDHI) Model 369D and E Helicopters**

##### **AD 99-13-09 MD Helicopters, Inc.:**

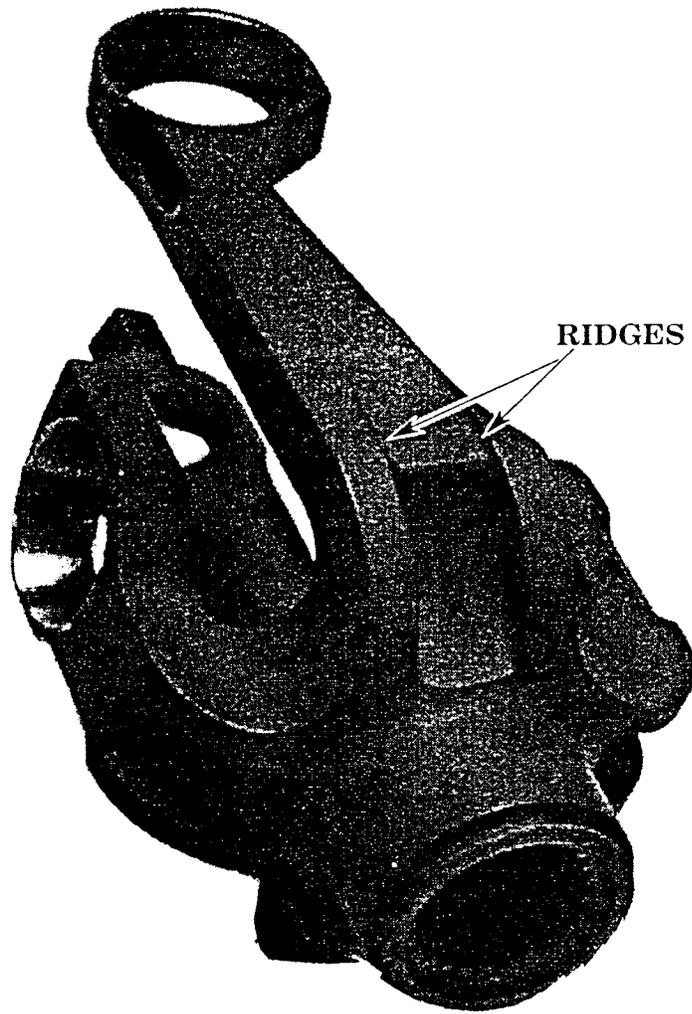
Figure 1. Fork Assembly with ridges (Sheet 1 of 2).

(a) Before further flight, inspect each fork assembly, P/N 369D21701-21, for the presence of ridges on the arms. See Figure 1, sheets 1 and 2.

(1) If ridges are found, no further action is required by this AD.

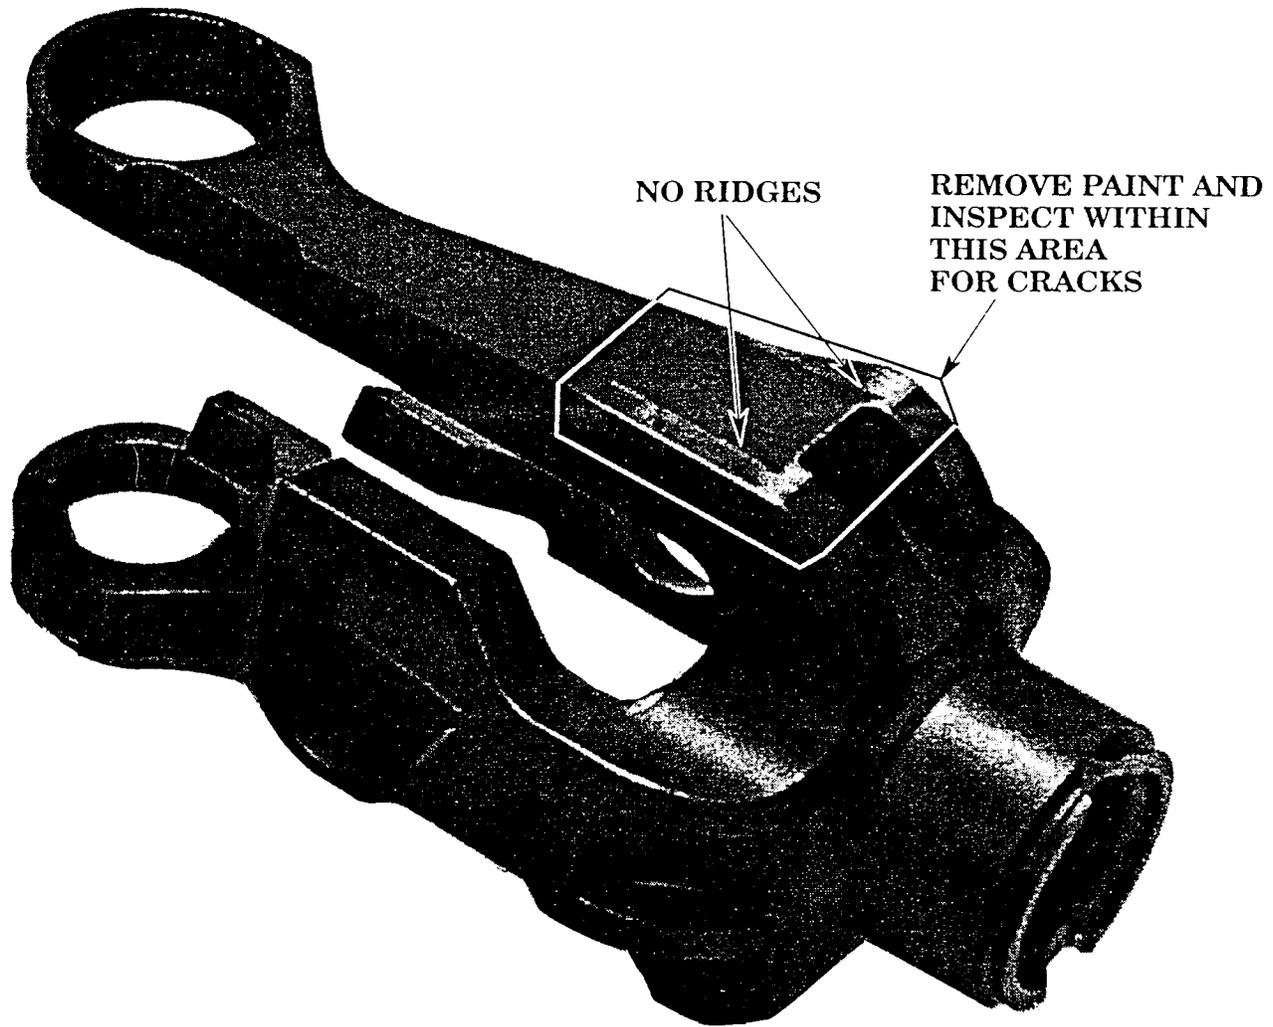
**Figure 1. Fork Assembly without ridges (Sheet 2 of 2).**

(2) If no ridges are found, chemically remove paint from the machined areas, inspect the fork assembly for a crack using the dye-penetrant procedure of MIL-STD-6866 or ASTM-E1417, and conduct a visual inspection using a 10X or higher magnifying glass. (See Figure 1, sheets 1 and 2.) Replace a cracked fork assembly with an airworthy fork assembly. A fork assembly without ridges, P/N 369D21701-21, may not be installed.

**Note 3:** The fork assembly is titanium, which requires dwell times for the dye-penetrant inspection that are appropriate for titanium.

(b) Thereafter, at intervals not to exceed 50 hours time-in-service (TIS), visually inspect each fork assembly without ridges, P/N 369D21701-21, for a crack using a 10X or higher magnifying glass. (See Figure 1, sheets 1 and 2.) If a crack is found, replace the cracked fork assembly with an airworthy fork assembly. A fork assembly without ridges, P/N 369D21701-21, may not be installed.

(c) Replacing an airworthy fork assembly with an airworthy fork assembly other than P/N 369D21701-21 without ridges constitutes terminating action for this AD.
