[Docket No. 2000-NM-67-AD; Amendment 39-11618; AD 2000-05-09]

Airworthiness Directives; Boeing Model 757-200, -200PF, and -200CB Series Airplanes Powered by Rolls-Royce RB211-535C/E4/E4B Turbofan Engines

2000-05-09 Boeing: Amendment 39-11618. Docket 2000-NM-67-AD. Supersedes AD 99-27-06, Amendment 39-11487.

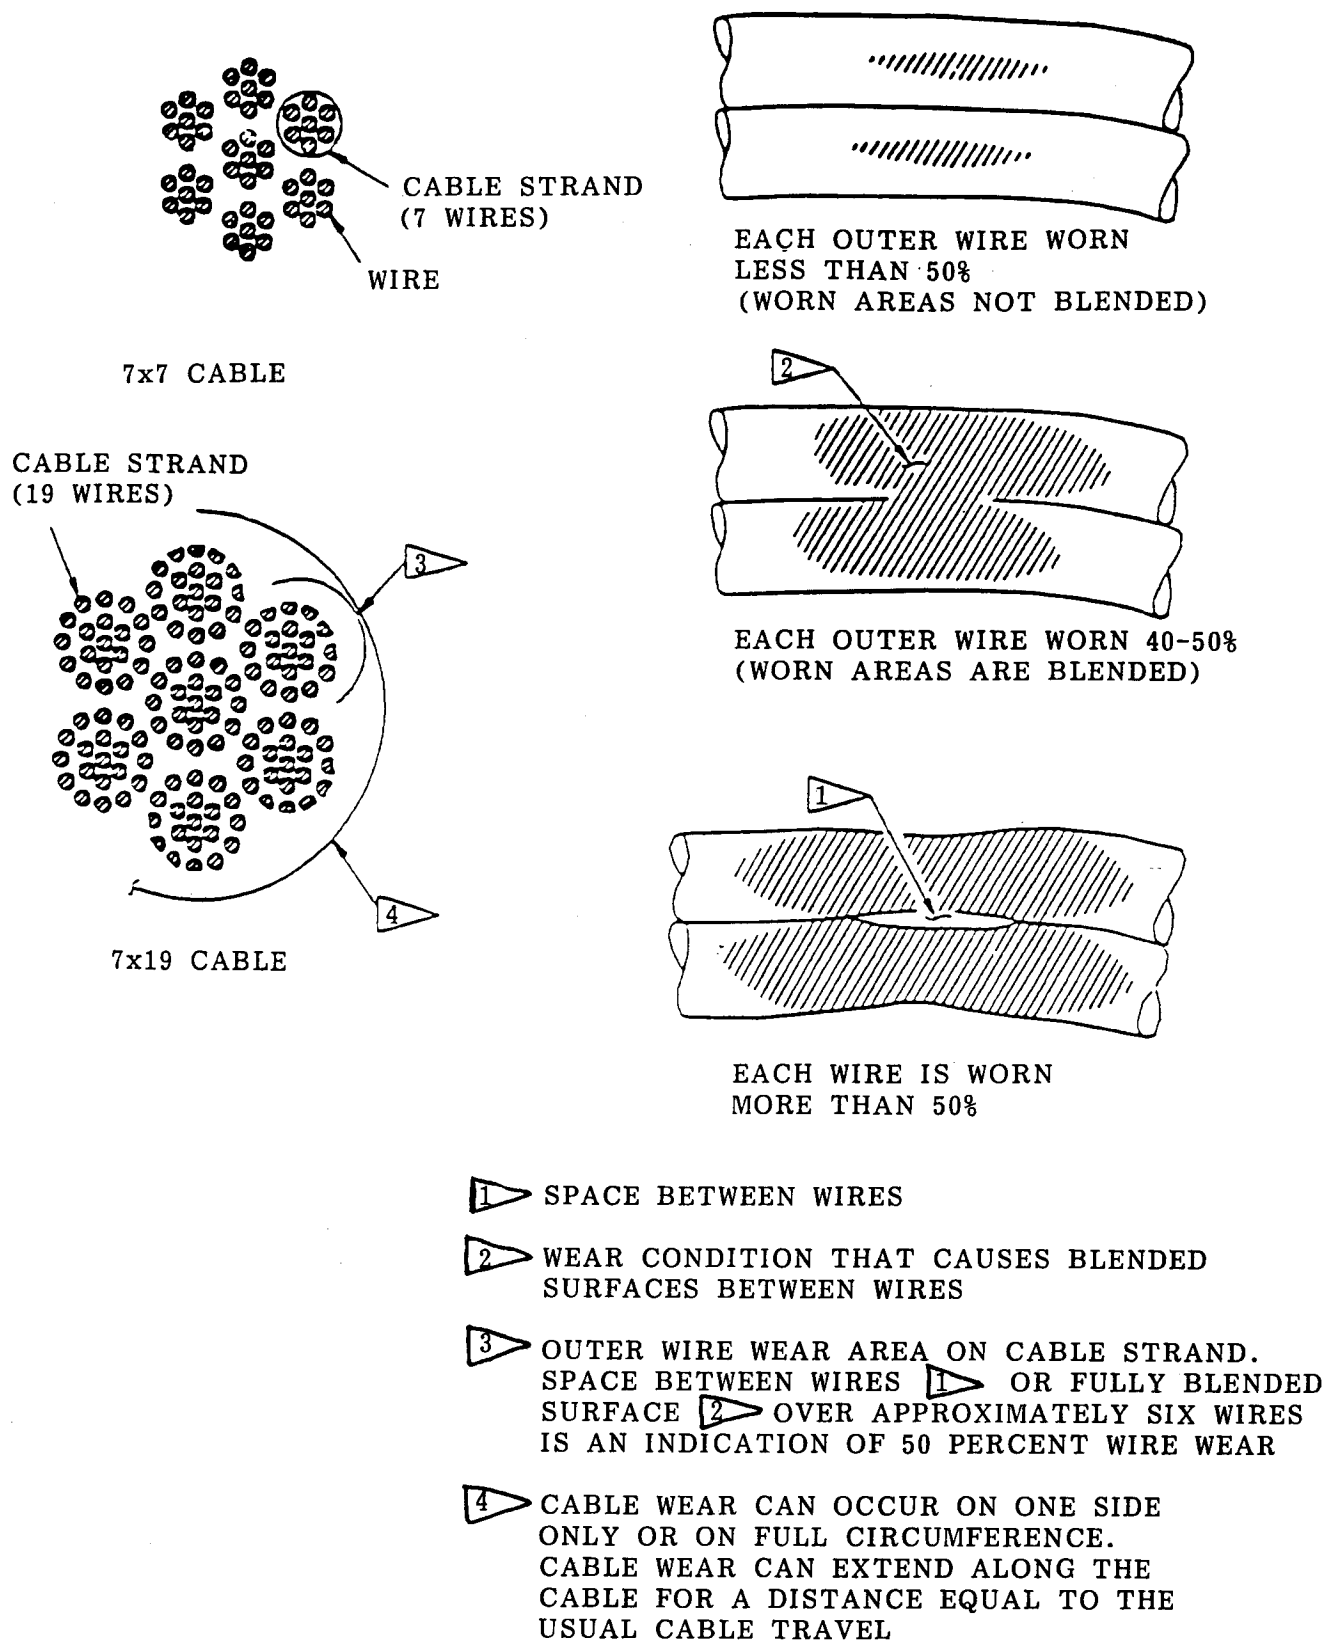
FIGURE 1

- (1) One cable strand had worn wires where one wire cross section is decreased by more than 40 percent (see Figure 1),
- (2) A kink is found, or
- (3) Corrosion is found.
