[Docket No. 2000-SW-12-AD]

Airworthiness Directives; Eurocopter France Model AS350B, B1, B2, BA, C, D, D1, and AS355E, F, F1, F2, and N Helicopters

ACTION: Notice of proposed rulemaking (NPRM).

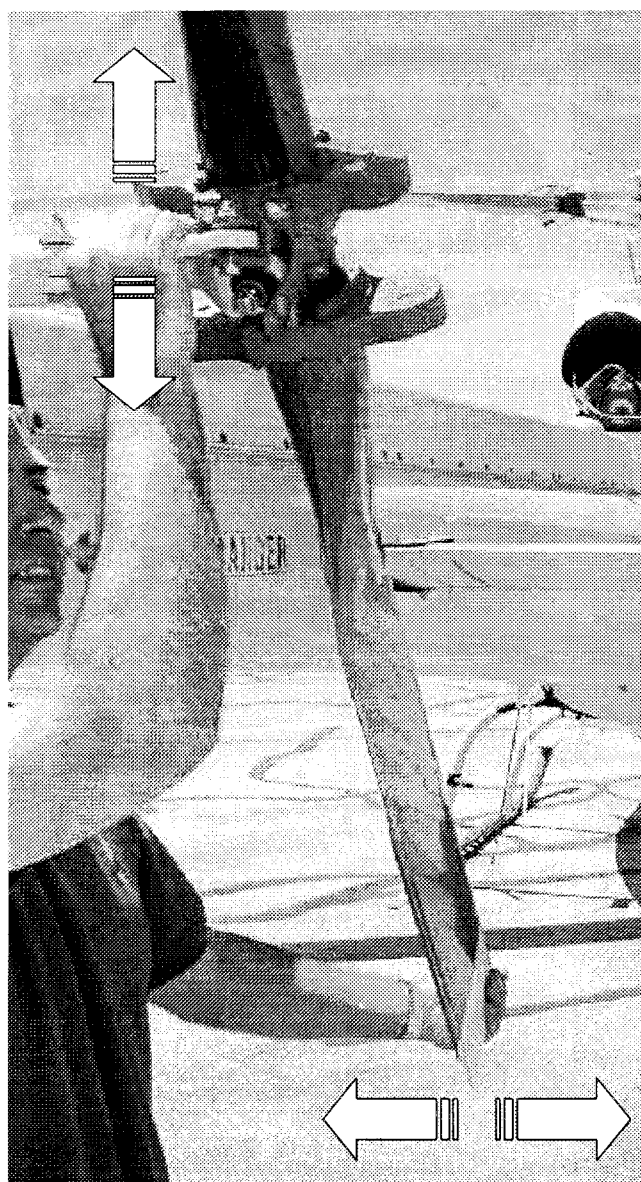
Figure 1: Manual Inspection for play of the Tail Rotor Pitch Control Rod

(a) Before the first flight of each day, configure the helicopter by ensuring the tail rotor pedals are in neutral position. If the helicopter is fitted with a tail rotor load compensator, discharge the accumulator as described in the flight manual. Inspect the bearing for play (Figure 1) on the helicopter, by observation and feel, by slightly moving the tail rotor blade in the flapping axis while monitoring the bearing for movement.

(1) If the Teflon cloth is found to be coming out of its normal position within the bearing, totally or partially, replace the control rod with an airworthy control rod before further flight.

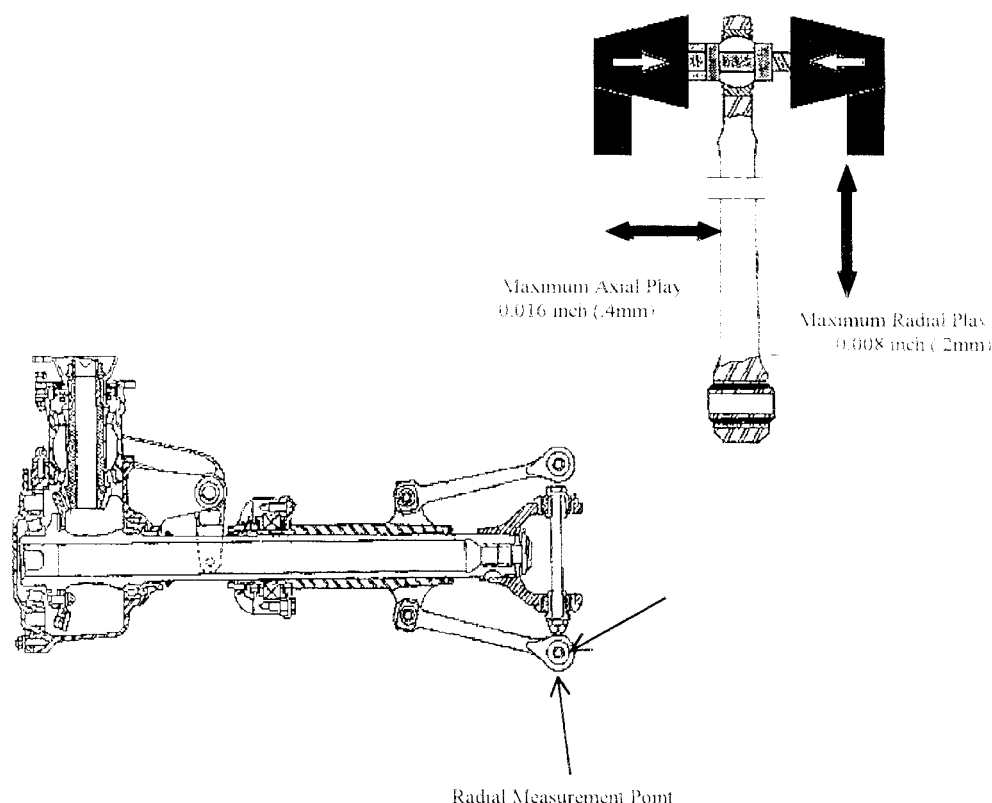
Figure 2. Play Measurement on Tail Rotor Pitch Control Rod

(2) If play is detected, measure the bearing wear using a dial indicator as shown in Figure 2. Perform the following steps (Figure 2) unless they were accomplished within the last 30 hours TIS.

(iv) Using a dial indicator, take two radial measurements in the areas shown by the two arrows.

(v) Take axial measurements in the area shown by an arrow.

(vii) If the radial play exceeds 0.008 inch or axial play exceeds 0.016 inch, replace the

control rod with an airworthy control rod before further flight.

(4) At intervals not to exceed 30 hours TIS, remove the control rod and measure the bearing wear with a dial indicator (Figure 2) using steps (a)(2)(i) through (a)(2)(vii).
