[Docket No. 2002–NE–07–AD; Amendment 39–12760; AD 2002–10–14]

#### Airworthiness Directives; Bombardier-Rotax GmbH 914 F Series Reciprocating Engines

**2002-10-14 Bombardier-Rotax GmbH:**  
Amendment 39-12760. Docket No. 2002-NE-07-AD.

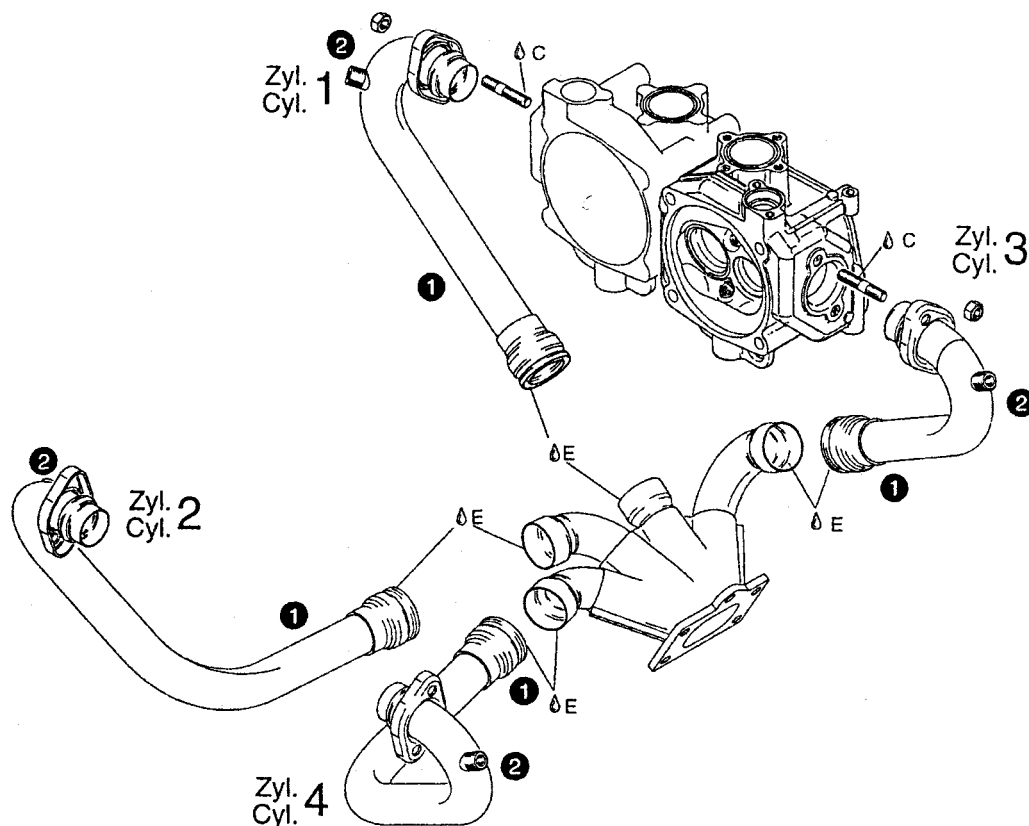
**Figure 1**

(a) Within 50 hours time-in-service (TIS) after the effective date of this AD, visually inspect the exhaust bend assemblies (item 1, Figure 1, of this AD), located between the cylinder heads and exhaust manifold assembly, for exterior traces of smoke, cracks, and damage, especially around the exhaust gas temperature (EGT) bosses (item 2). Replace any exhaust bend assembly found cracked. Figure 1 follows:

1) Exhaust Bend Assembly

2) EGT Boss

(b) Thereafter, inspect the exhaust bend assemblies every additional 50 hours TIS. Replace any exhaust manifold assembly found cracked.

(c) If any exhaust bend assembly is replaced, perform a ground test run and exhaust leakage test.
