#### DEPARTMENT OF TRANSPORTATION

[Docket No. 2002–SW–17–AD]

##### Airworthiness Directives; Eurocopter France Model AS 350B3, SA–365N, N1, AS–365N2, AS 365N3, and EC 155B Helicopters

**ACTION:** Notice of proposed rulemaking (NPRM).

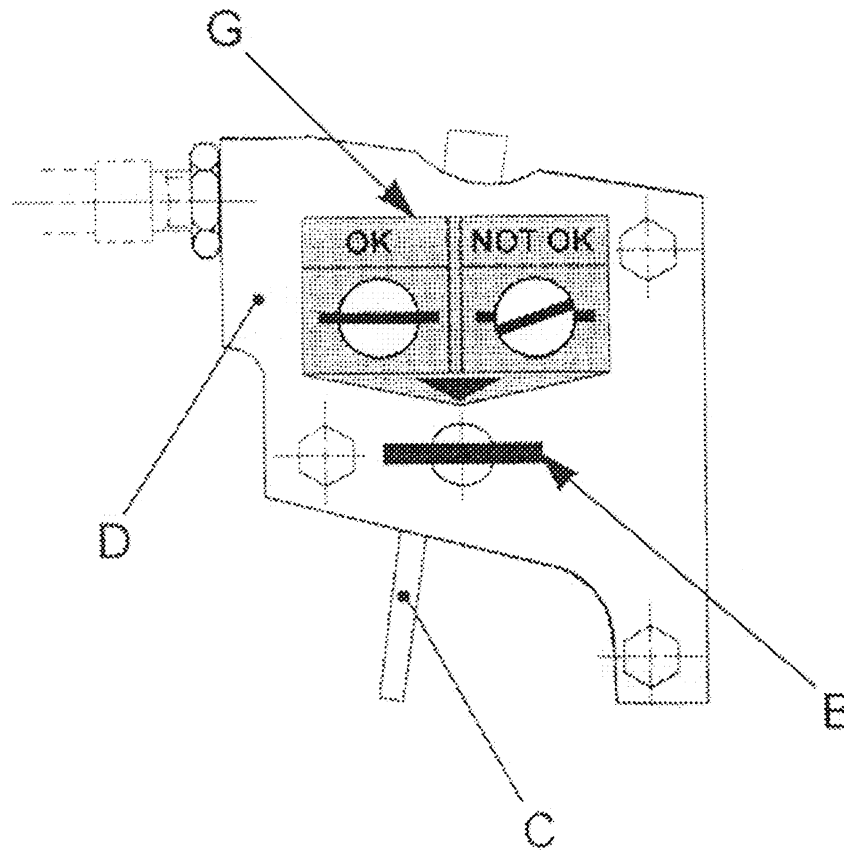
To detect internal corrosion of the Siren cargo hook locking catch (locking catch), which can cause the locking catch to return to an incomplete locking position, undetectable by the operator, and result in an unexpected cargo load release, accomplish the following:

(a) For cargo hook, P/N AS-21-5-7, with Amendment B incorporated, before the first use of the cargo hook on each day that the cargo hook is used, check for corrosion on the locking catch as follows. Amendment B has been incorporated if the letter "B" is marked on the amendment identification plate of the release unit of the cargo hook and placard "G" is installed on the release unit cover plate "D" and reference line "B" is marked over the nut and cover plate as depicted in Figure 1 of this AD. The identification plate is located on cover plate "D", on the opposite side of the electrical connector. See Figure 1:

(3) Determine whether the section of reference line (B) marked on the bolt (A) and the section of reference line (B) marked on the cover plate (D) form a straight line.

(i) If the reference line is straight, the cargo hook is considered airworthy.

(ii) If the reference line is not straight, the cargo hook is unairworthy and may not be used.

(c) For cargo hook, P/N AS-21-5-7, without Amendment B, before the next sling load flight, incorporate Amendment B to the cargo hook in accordance with the Accomplishment Instructions, paragraphs 2.A.2.(a) and 2.A.2.(b), of Alert No. 05.00.39, for Model AS 350B3 helicopters; No. 05.00.41, for Model SA-365N, N1, AS-
