[Docket No. 2004-NE-07-AD; Amendment 39-13579; AD 2004-08-10]

#### Airworthiness Directives; Engine Components Incorporated (ECi) Reciprocating Engine Cylinders

#### 2004-08-10 Engine Components

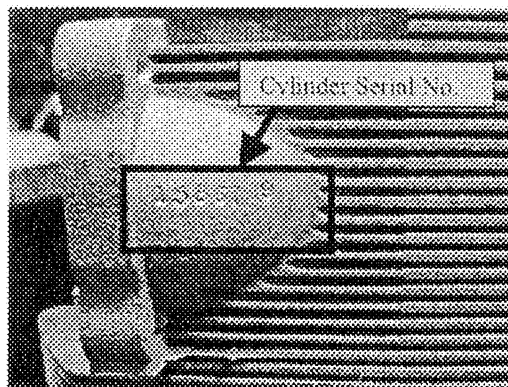
Figure 1.

(i) Determine the SN of the cylinder by looking in the engine records or by inspecting the cylinder for a SN on the intake port boss (see Figure 1) or on the flat area next to the head to barrel junction (see Figure 2). Disregard any dash numbers that might follow the four digit SN.

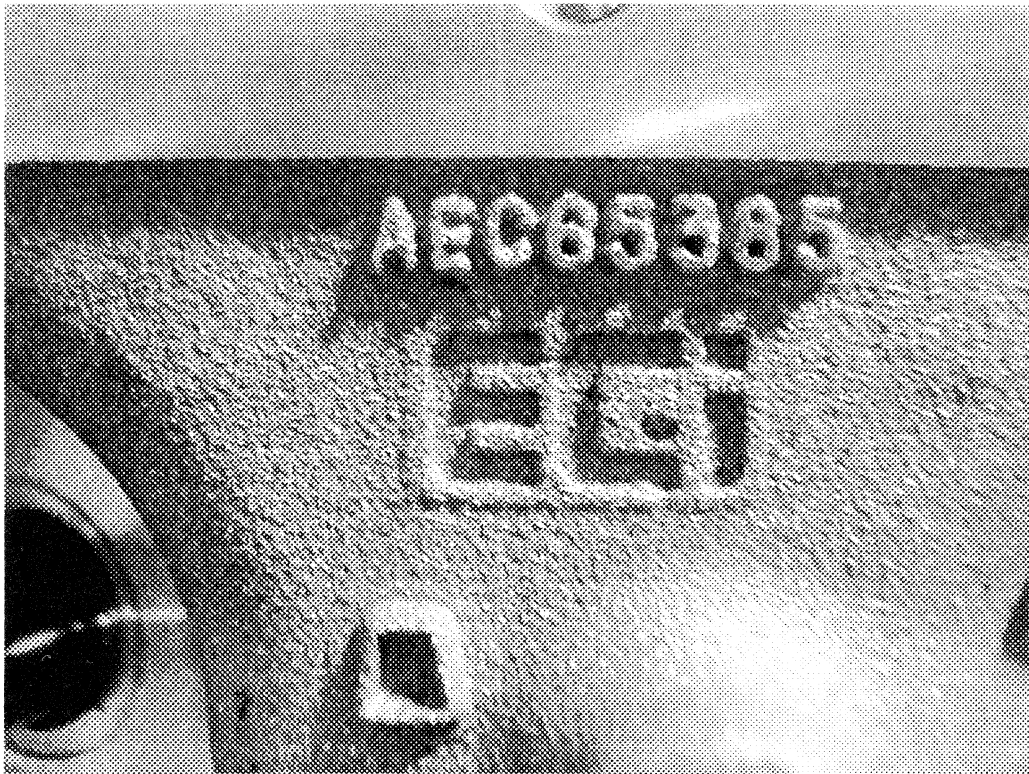
(iii) If the casting has AEC65385, and an "O" under the ECi logo, the cylinder is P/N AEC631397. See Figure 3.

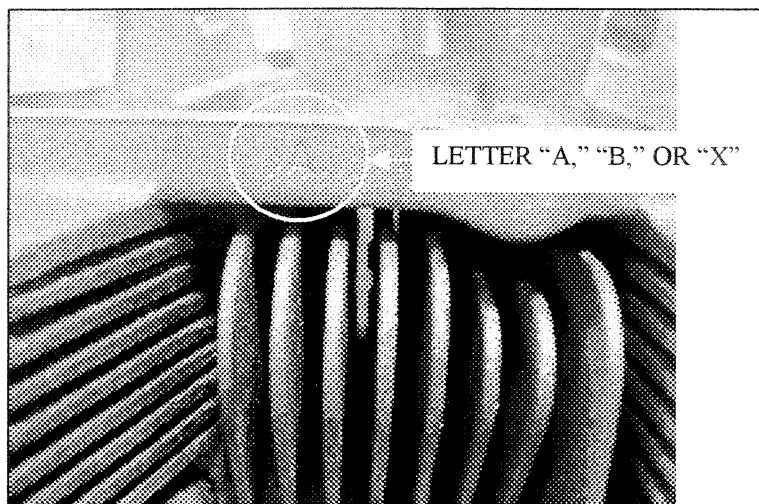
(ii) If there is a letter "A," "B," or "X" stamped on the flange of the rocker box, no further action is required. See Figure 4.

(iii) If there is no letter "A," "B," or "X" stamped on the flange of the rocker box, replace the cylinder before further flight.
