[Docket No. 2002–SW–25–AD; Amendment 39–13709; AD 2003–13–15 R1]

**Airworthiness Directives; Schweizer Aircraft Corporation Model 269A, 269A–1, 269B, 269C, and TH–55A Helicopters**

**ACTION:** Final rule.

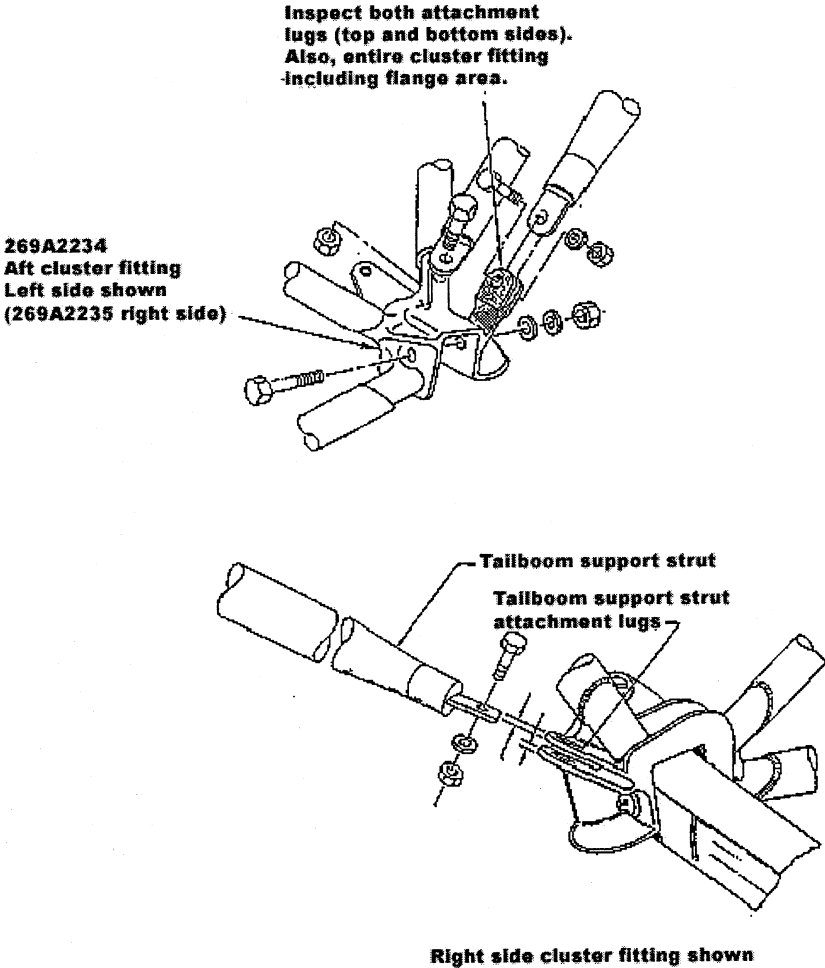
Figure 1

hours TIS, for helicopters with cluster fittings, P/N 269A2234 or P/N 269A2235:  
(1) Using paint remover, remove paint from the lugs on each cluster fitting. Wash with water and dry. The tailboom support strut must be removed prior to the paint stripping.  
(2) Dye-penetrant inspect the lugs on each cluster fitting. See the following Figure 1:

(3) If a crack is found, before further flight, replace the cracked cluster fitting with an airworthy cluster fitting.
