Federal Register

[Docket No. 2004–SW–04–AD; Amendment 39–13812; AD 2004–20–07]

Airworthiness Directives; Bell Helicopter Textron Canada Model 222, 222B, 222U, and 230 Helicopters

ACTION: Final rule.

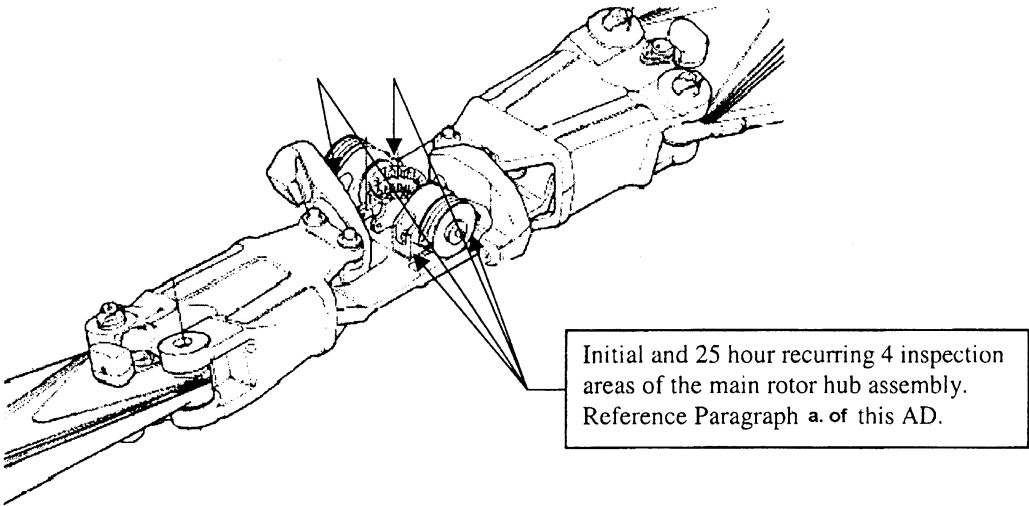
Figure 1. Main Rotor Hub Assembly

Transport Canada, the airworthiness authority for Canada, notified the FAA that an unsafe condition may exist on BHTC Model 222, 222B, 222U, and 230 helicopters. Transport Canada advises of a fatigue crack being found in a yoke in the area of the flapping bearing bushings.

for a crack, fretting or buffer deterioration in the four areas around the flapping bearing attachment bushings as shown in the following Figure 1 of this AD:

(1) If a crack is found, before further flight, replace the yoke with an airworthy yoke.

(2) If fretting or buffer deterioration is found on the yoke in the areas shown in Figure 1 of this AD, before further flight, disassemble the hub assembly and further

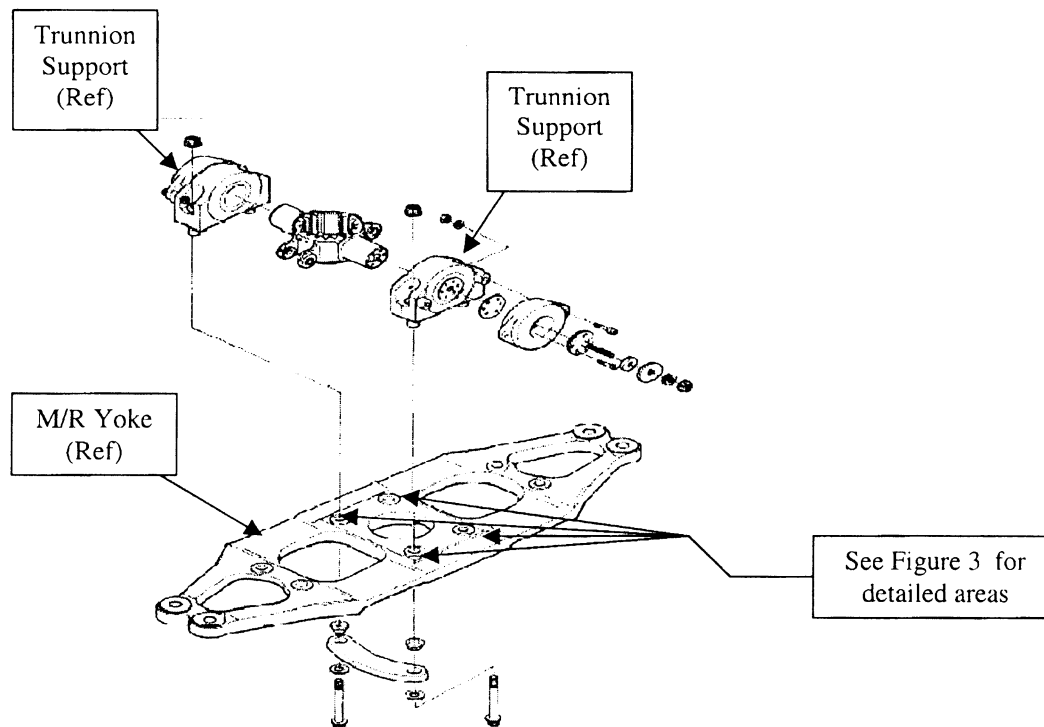
Figure 2. Main Rotor Yoke

inspect the yoke with a 10X or higher magnifying glass in the four areas shown in Figures 2 and 3 of this AD.

Shown with trunnion supports removed.

(i) If a crack is found on any part, before further flight, replace the part with an airworthy part.

(ii) If fretting or buffer deterioration is found on any part, before further flight, repair any unairworthy part or replace the part with an airworthy part.
