[Docket No. 2003-SW-38-AD]

#### **Airworthiness Directives; Eurocopter Deutschland Model MBB-BK 117 A-1, A-3, A-4, B-1, B-2, and C-1**

**ACTION:** Notice of proposed rulemaking (NPRM).

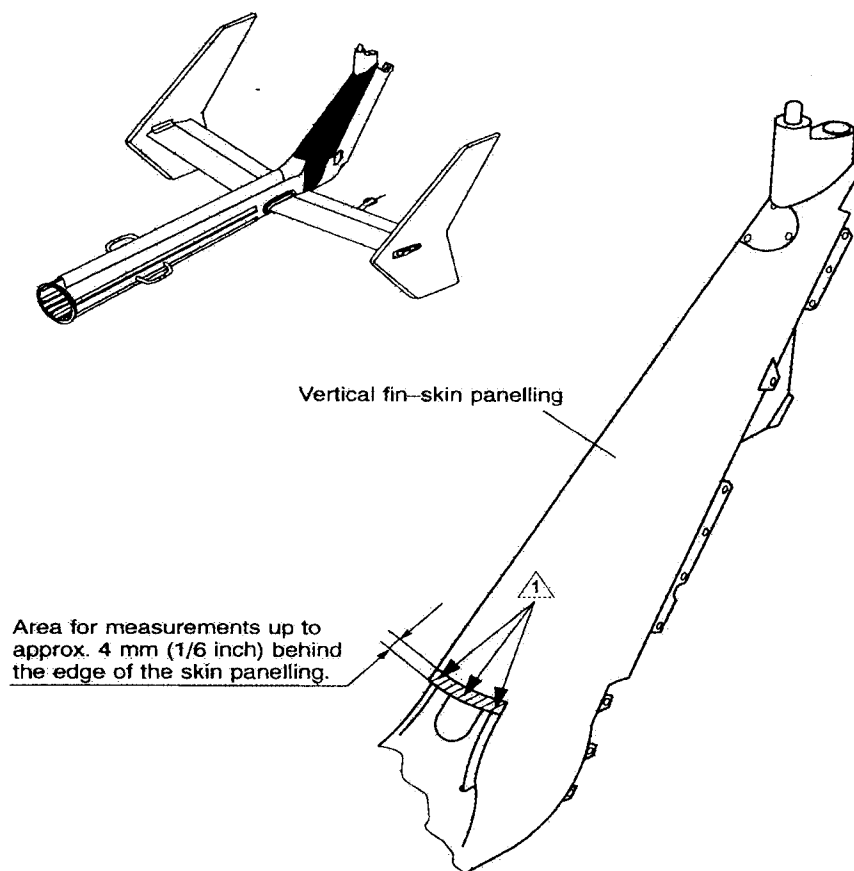
Vertical Fin-Skin Panelling  
Figure 1

Model A-1 up to B-2, serial number (S/N) all, and Model C-1, S/N 7500 up to 7545. The LBA advises that during tail boom production, metal sheeting of 0.6-millimeter (mm) thickness was found instead of the specified 0.8-mm thickness for the skin paneling of several tail booms.

(a) Using external calipers, measure the wall thickness, including primer coating, of the skin paneling of the vertical fin at the locations shown in Figure 1 of this AD.

- △ Measurements are to be taken at at least three locations on the skin panel of the vertical fin. Care has to be taken that the external calipers are held squarely to the skin panel wall while measurements are being taken, since tilting of the calipers can lead to false results. If the panel thickness, including the primer coating, is at least 0.778 mm (0.03063 inch) at every measured location, no further action is necessary.

(b) If the wall thickness, including the primer coating, of the panelling is less than 0.778 millimeter (0.03063 inch) at any of the measured locations, replace the vertical fin with an airworthy part before further flight.
