[Docket No. 2004-SW-12-AD; Amendment 39-13884; AD 2004-24-08]

Airworthiness Directives; Bell Helicopter Textron Canada Model 206A, B, L, L-1, L-3, and L-4 Helicopters

2004-24-08 Bell Helicopter Textron

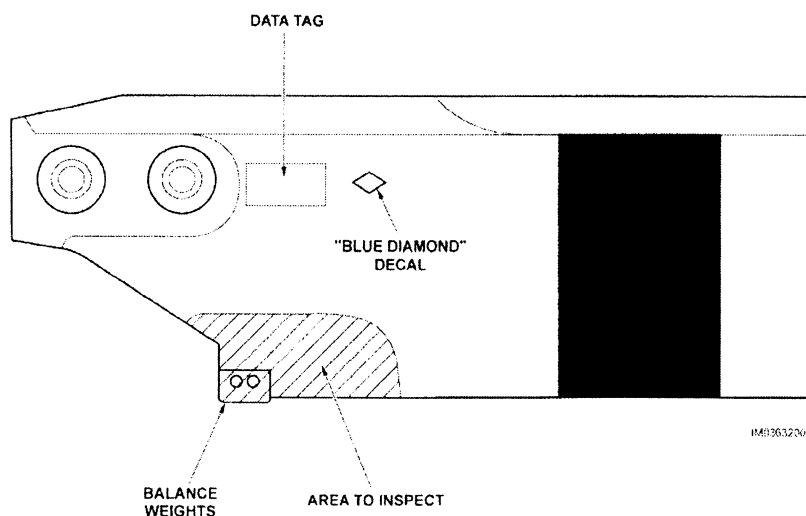
Figure 1. Tail rotor blade inspection.

installing any blade with a P/N and S/N listed in the applicability section of this AD, clean the blade. Using a 10X or higher magnifying glass, inspect both sides of each blade for a deformation, a

crack, and a bent or deformed weight in the area shown in Figure 1 of this AD.

Note 1: Paint irregularities on the blade may indicate a crack.

(1) At intervals not to exceed 12 hours time-in-service (TIS), using a 10X or higher magnifying glass, inspect both sides of each blade for a deformation, a crack, and a bent or deformed weight in the area shown in Figure 1 of this AD, or

(2) Inspect and check both sides of each blade for a deformation, a crack, and a bent or deformed weight in the area shown in Figure 1 of this AD as follows:

(c) Before further flight, replace any blade that has a deformation, a crack, or a bent or deformed weight with an airworthy blade.
