#### Airworthiness Directives; Schweizer Aircraft Corporation Model 269A, 269A-1, 269B, 269C, and TH-55A Helicopters

**ACTION:** Notice of proposed rulemaking (NPRM).

**Schweizer Aircraft Corporation:** Docket No. 2002-SW-25-AD. Revises AD 2003-13-15, Amendment 39-13217.

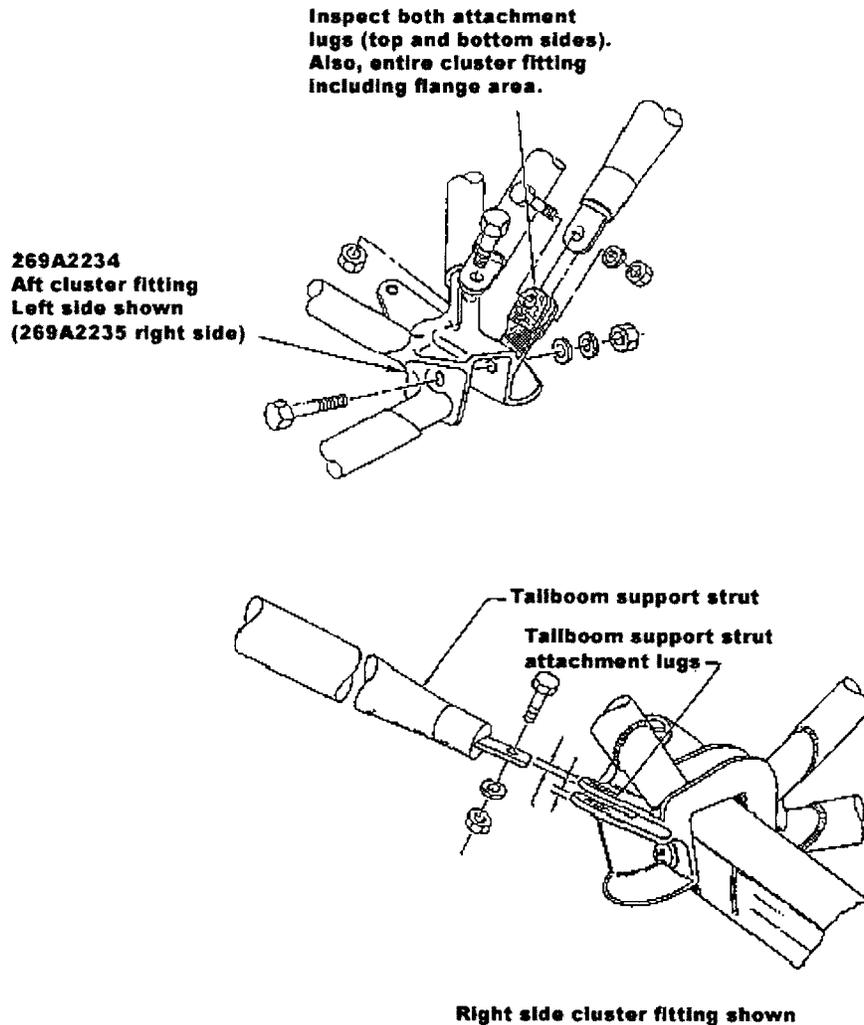
**Figure 1**

(2) Dye-penetrant inspect the lugs on each cluster fitting. See the following Figure 1:

(3) If a crack is found, before further flight, replace the cracked cluster fitting with an airworthy cluster fitting.
