[Docket No. 2003-SW-21-AD; Amendment 39-13424; AD 2004-01-10]

Airworthiness Directives; Eurocopter Deutschland Model MBB-BK-117 A-1, A-3, A-4, B-1, B-2, and C-1 Helicopters

2004-01-10 Eurocopter Deutschland:

Amendment 39-13424. Docket No. 2003-SW-21-AD.

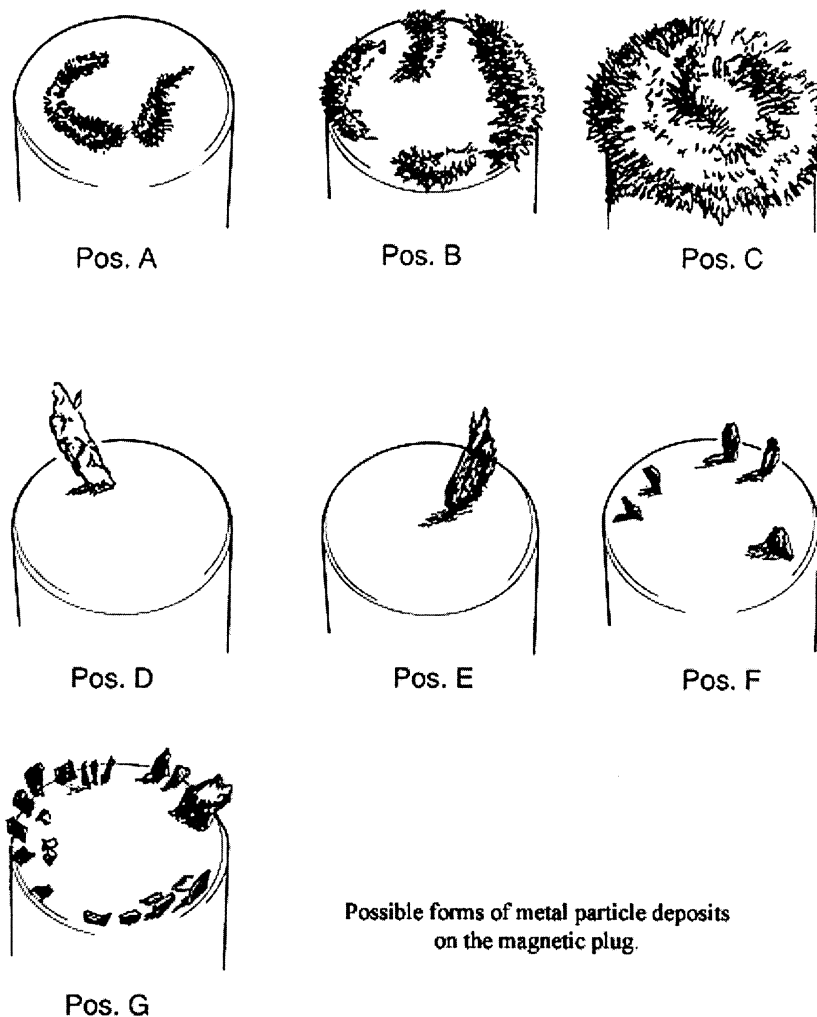
day. If a small amount of fuzz is found on the magnetic plug, the magnetic plug must be cleaned and may be reinstalled. If there is an amount of fuzz that exceeds the amount depicted in "Pos. A" of Figure 1 of this AD, then replacing the INT gearbox, TR transmission, or bearing, part number (P/N) 4639310006, with serial number (S/N) 3246 through 3598, is required within 30 days after the effective date of this AD. The short compliance time involved is required because the previously described critical unsafe condition can adversely affect the controllability and structural integrity of the helicopter. Therefore, the inspections and replacement, if necessary, are required before further flight and this AD must be issued immediately.

(1) If you find a small amount of fine fuzz as shown in "Pos. A" of Figure 1 of this AD, clean the magnetic plug and reinstall it after ensuring that the O-ring is correctly positioned and there is no other damage.

(2) If you find an amount of fuzz as depicted in "Pos. B" or "Pos. C" or metal chip(s) as depicted in "Pos. D" through "Pos. G" or a combination of both fuzz and chips, do paragraph (b) of this AD.

(b) No later than February 23, 2004, replace bearing, P/N 4639310006 with S/N 3246 through 3598, with an airworthy bearing or replace the affected TR transmission or INT gearbox with an airworthy TR transmission and INT gearbox that does not contain the affected bearing.
