[Docket No. FAA-2004-19960; Directorate Identifier 2004-CE-47-AD; Amendment 39-14153; AD 2005-13-16]

#### Airworthiness Directives; The New Piper Aircraft, Inc. PA-34 Series Airplanes

**2005-13-16 The New Piper Aircraft, Inc.:**  
Amendment 39-14153; Docket No. FAA-2004-19960; Directorate Identifier 2004-CE-47-AD.

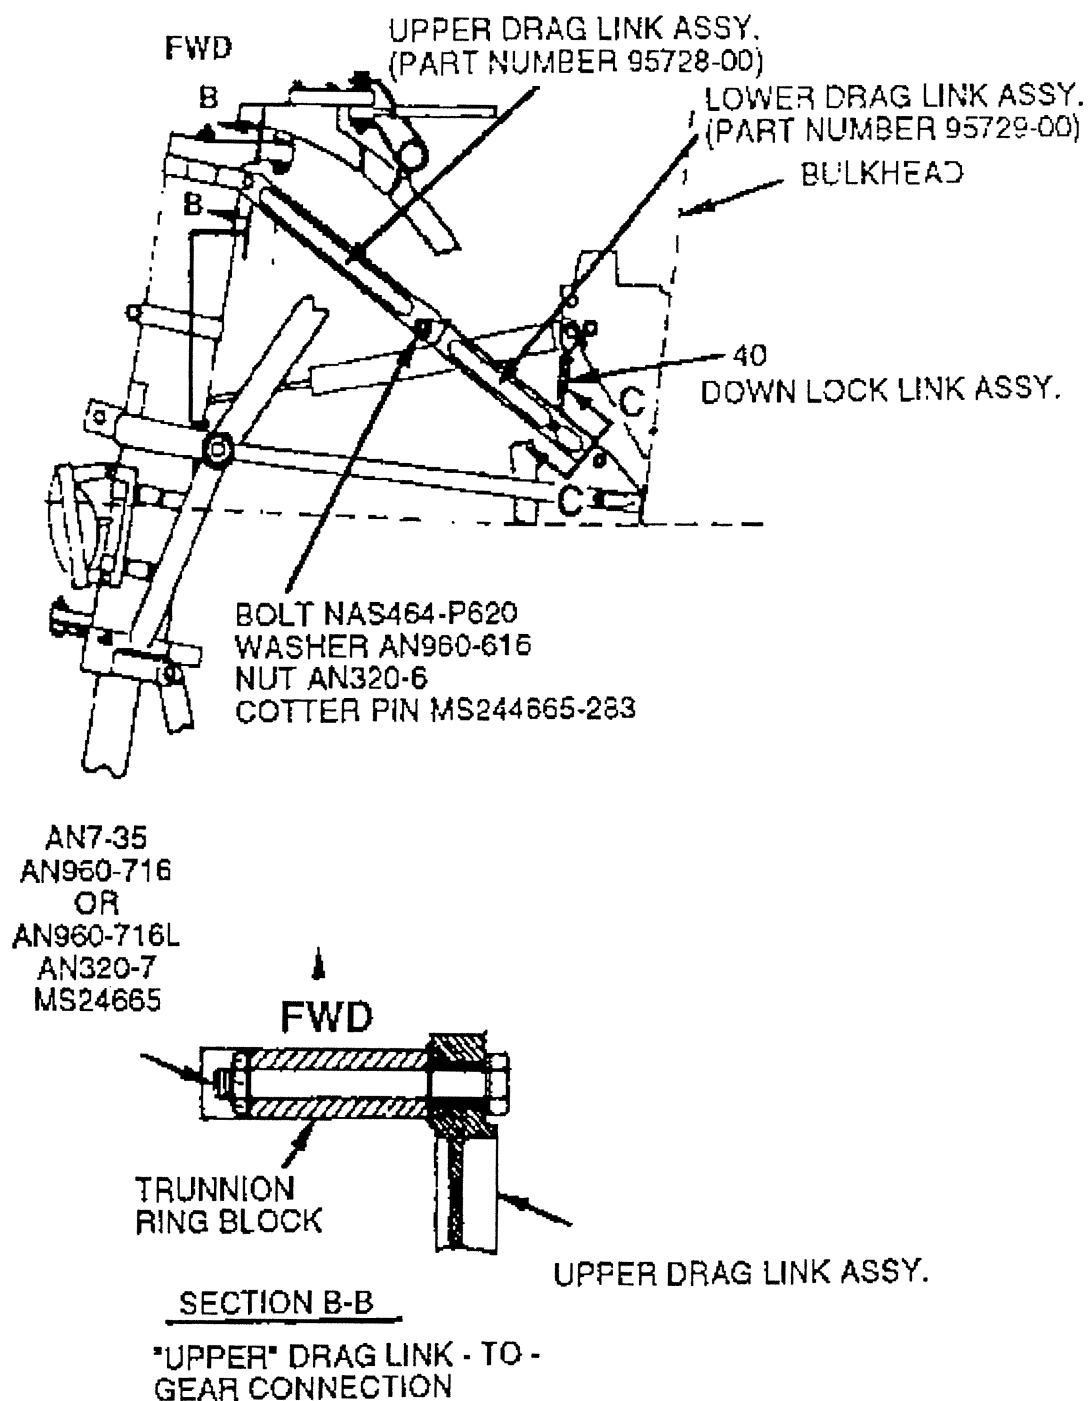
Figure 1.

Actions	Compliance	Procedures
<p>(1) Replace the bolt and stack up that connects the upper drag link to the nose gear trunnion with new parts (or FAA-approved equivalent part numbers (P/N)) of the following:</p> <ul style="list-style-type: none"> <li>(i) Piper P/N 400 274 (AN7-35) bolt;</li> <li>(ii) Piper P/N 407 591 (AN960-716L) washer, as applicable;</li> <li>(iii) Piper P/N 407 568 (AN960-716);</li> <li>(iv) Piper P/N 404 396 (AN320-7) nut; and</li> <li>(v) Piper P/N 424 085 cotter pin.</li> </ul> <p>(2) Do the inspections, replacements, and other corrective actions specified in Table 1 "Specified Maintenance" of Piper Service Bulletin No. 1123A, dated November 30, 2004.</p> <p>(3) Do any necessary corrective actions as a result of the actions specified in Table 1 "Specified Maintenance" of Piper Service Bulletin No. 1123A, dated November 30, 2004.</p>	<p>Within the next 100 hours time-in-service (TIS) after January 28, 1994 (the effective date of AD 93-24-14), unless already done within the last 400 hours TIS before January 28, 1994 (compliance with AD 93-24-14). Repetitively replace thereafter at intervals not to exceed 500 hours TIS. Continue to repetitively replace until the actions in paragraphs (e)(2) and (e)(3) of this AD begin.</p> <p>Within the next 100 hours TIS after August 8, 2005 (the effective date of this AD), unless already done. Repetitively inspect thereafter at the intervals referenced in the Inspection Time column of the <i>INSTRUCTIONS</i> paragraph in Piper Service Bulletin No. 1123A, dated November 30, 2004.</p> <p>Before further flight after any action required by paragraph (e)(2) of this AD.</p>	<p>Follow Figure 1 of this AD.</p> <p>Follow The New Piper Aircraft, Inc. Service Bulletin No. 1123A, dated November 30, 2004.</p> <p>Follow The New Piper Aircraft, Inc. Service Bulletin No. 1123A, dated November 30, 2004.</p>
