2007–05–51 MD Helicopters Inc. (MDHI):
Amendment 39–15030. Docket No. FAA–2007–27343; Directorate Identifier 2007–SW–05–AD.

Applicability: Model MD600N helicopters, with a lateral mixer output link assembly (mixer link), part number (P/N) 600N7636–1, –3, –9, or –11 installed, certificated in any category.

To detect a crack in the mixer link, which could result in failure of the mixer link and subsequent loss of control of the helicopter, accomplish the following:

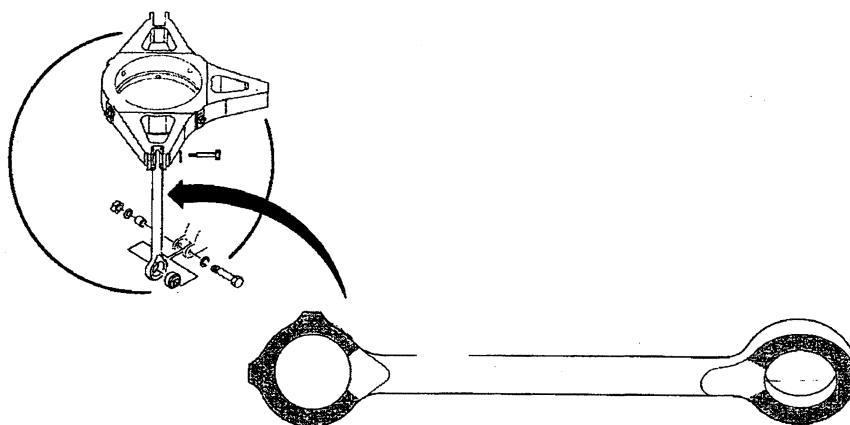
Figure 1

(1) Remove each mixer link and visually inspect, with a bright light and a 10x or higher magnifying glass, the shaded areas around the bearing bore for any crack as depicted in the following Figure 1:

Bearings have been removed for clarity.

(2) Perform an eddy current inspection of each mixer link in the bearing end areas.

(3) Replace any cracked mixer link with an airworthy mixer link on which an eddy current inspection has been performed.
