[Docket No. FAA-2007-0096; Directorate Identifier 2007-NE-39-AD]

#### **Airworthiness Directives; Honeywell International Inc. ALF502 Series and LF507 Series Turbofan Engines**

**ACTION:** Notice of proposed rulemaking (NPRM).

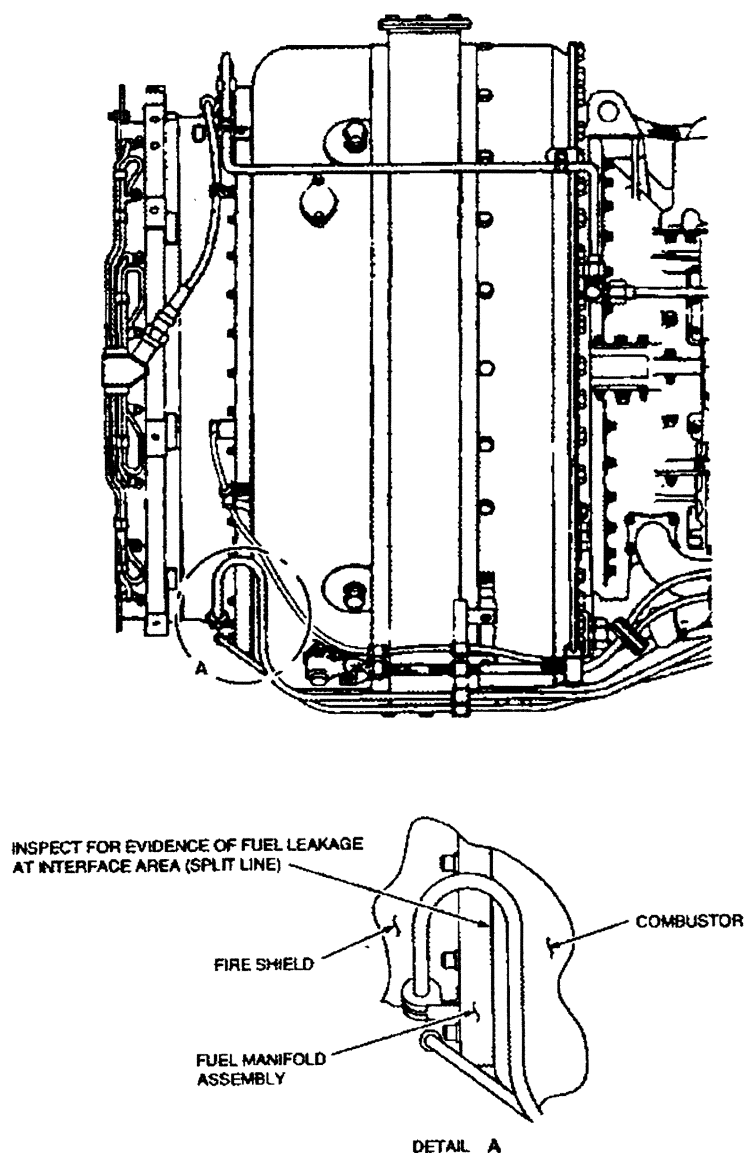
Figure 1 - Fuel Manifold Assembly-to-Fire Shield Interface Area

Since we issued that AD, we have received reports of about 36 events of fuel leaking at the fuel nozzles on fuel manifold assemblies, P/Ns 2-163-620-37 and 2-163-620-38, due to loosening of the fuel nozzles. Failure to detect and remove a leaking manifold assembly is likely to result in a fire in the engine nacelle and create a hazard to the aircraft.

(2) With the engine operating, look for fuel leaking from the fuel manifold assembly to the fire shield interface area (see Figure 1). No leaks allowed.

(5) Look for fuel leaking from the fuel manifold assembly to the fire shield interface area (see Figure 1.) No leaks allowed.

(3) If you find any leaks, shut down the engine and replace the fuel manifold assembly with an FAA approved serviceable assembly.

(6) If you find any leaks, replace the fuel manifold assembly with an FAA approved serviceable assembly.
