[Docket No. FAA-2011-1115; Directorate Identifier 2010-SW-011-AD; Amendment 39-17017; AD 2012-08-01]

#### Airworthiness Directives; Sikorsky Aircraft Corporation Helicopters

##### 2012-08-01 Sikorsky Aircraft Corporation:

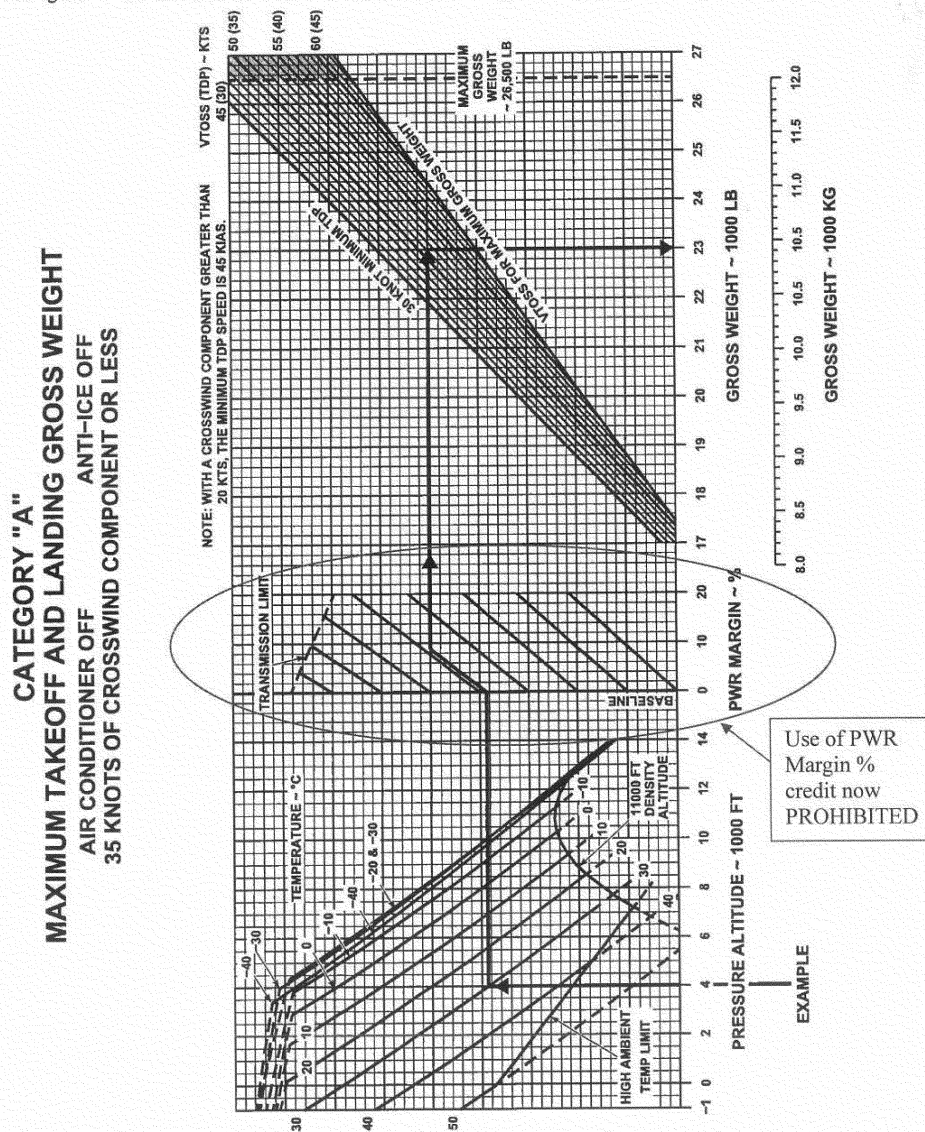
Figure 1. Cat 'A' Takeoff and Landing Gross Weight

(2) If the RFM already contains the revisions appropriate for your helicopter as listed in the following Table 1, all dated April 9, 2008, with the correct performance charts, without the performance credit as depicted in the circled area of Figure 1 of this AD, the operating limitation required by paragraph (1) of this AD does not need to be inserted into the RFM.

**Note to paragraph (e)(2) of this AD:**  
Previous RFM revisions allowed for the use of above-specification engine power margin as depicted in the circled area of Figure 1 of this AD.

(1) By making pen and ink changes, insert into the Operating Limitations section, Part 1, Section 1, Weight Limits, of Rotorcraft Flight Manuals (RFMs) SA S92A-RFM-002, -003, -004, -005, and -006 the following limitation “Performance credit for above specification engine power margin is prohibited.”
