[Docket No. FAA-2012-0060; Directorate Identifier 2012-NE-02-AD; Amendment 39-17123; AD 2012-14-09]

#### Airworthiness Directives; Pratt & Whitney (P&W) Division Turbofan Engines

**2012–14–09 Pratt & Whitney Division:**  
Amendment 39–17123; Docket No. FAA–2012–0060; Directorate Identifier 2012–NE–02–AD.

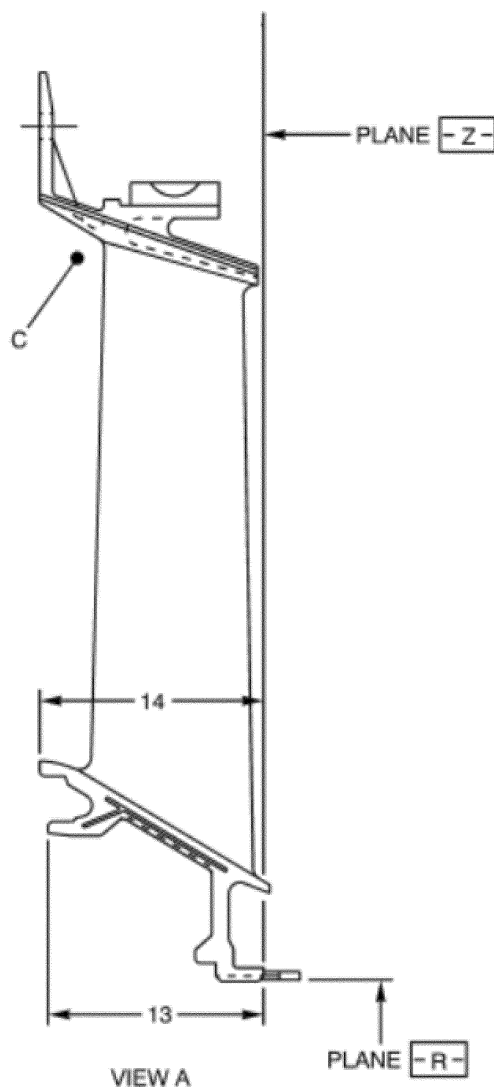
**Figure 1 to Paragraph (e) - Determination of Vane Eligibility**

(iii) Dimensionally examine index 13 through index 34 of the LPT 3rd stage vane cluster assembly. Use Table 2 to paragraph (e) of this AD and Figure 1, Figure 2, and

Figure 3 to paragraph (e) of this AD to determine whether the vane is eligible for installation.

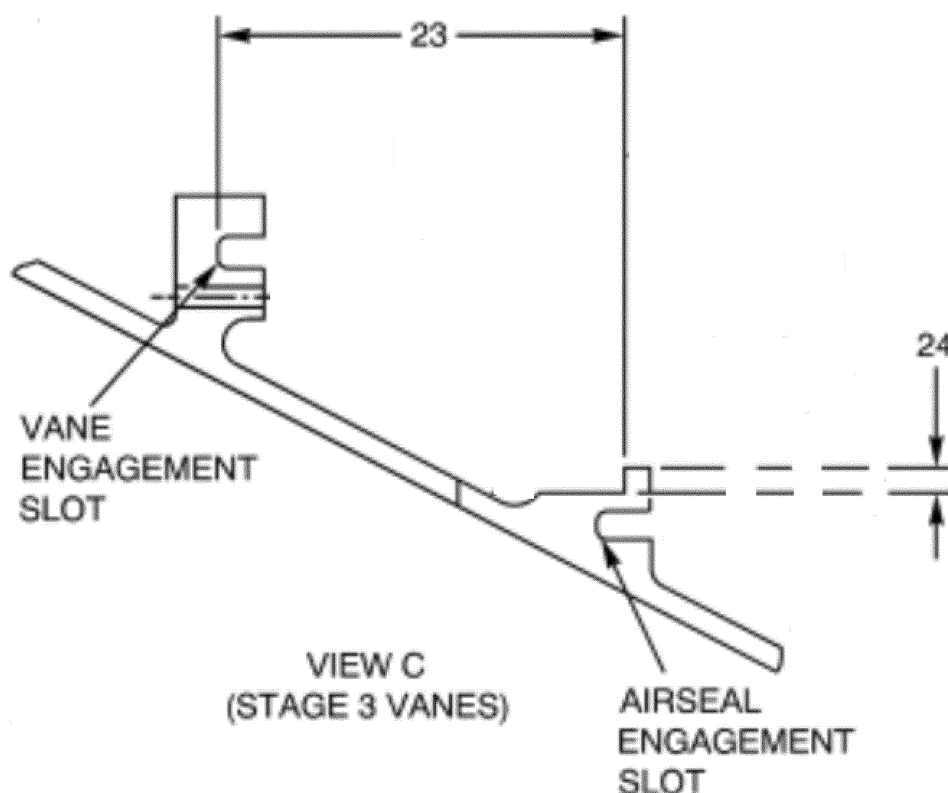
Figure 4 to Paragraph (e) - Determination of Case Eligibility

(iv) Dimensionally examine index 23 and index 24 of the vane engagement slots on the rear turbine case, where the 3rd stage vane is installed. Use Table 3 to paragraph (e) of this AD and Figure 4 to paragraph (e) of this AD to determine whether the case is eligible for installation.

Inspect:	Eligible for installation limits:
24 .....	0.097 inch (2.464 mm) minimum.

Inspect:	Eligible for installation limits:
23 .....	1.875 inch (47.625 mm) minimum.
