[Docket No. FAA-2012-0861; Directorate Identifier 2012-NM-074-AD; Amendment 39-17364; AD 2013-04-07]

#### Airworthiness Directives; Bombardier, Inc. Airplanes

**ACTION:** Final rule.

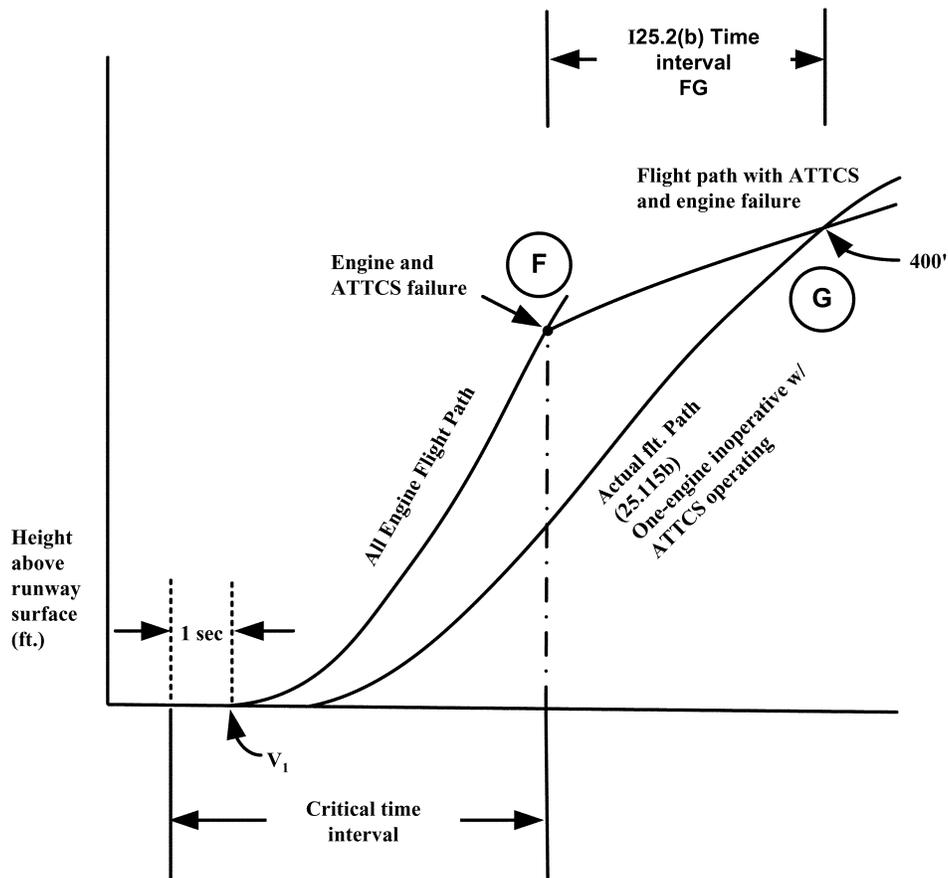
Figure 2. Appendix I25.2(b), "Critical Time Interval" Illustration (ATTCS takeoff)

**Note:** Figure 2 is included for reference and clarity to show time interval FG. It has not been included in previous special conditions on the same subject and does not include any new requirements. It does not change the meaning or intent of the special conditions.
