[Docket No. FAA-2013-0724; Directorate Identifier 99-CE-013-AD]

Airworthiness Directives; Piper Aircraft, Inc. Airplanes

ACTION: Notice of proposed rulemaking (NPRM).

SUMMARY: We propose to revise airworthiness directive (AD) 99-26-19 that applies to certain The New Piper Aircraft, Inc. Model J-2 airplanes equipped with wing lift struts. AD 99-

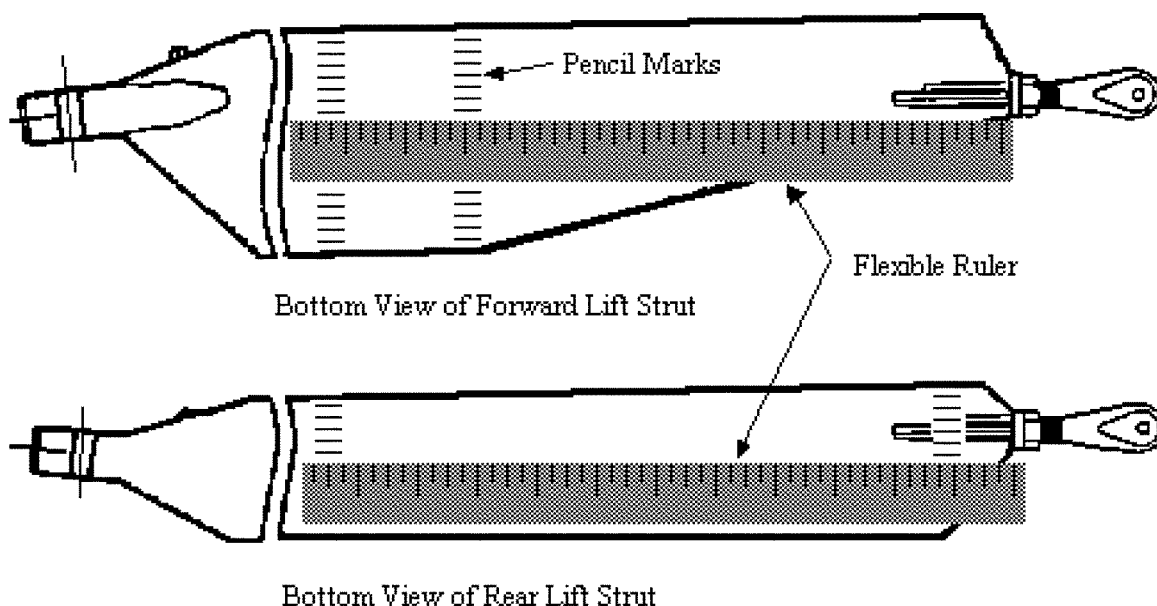
Figure 1

8. A measurement of 0.024-inch or less shall require replacement of the strut prior to further flight.
