[Docket No. FAA-2013-0019; Directorate Identifier 2010-SW-051-AD]

**Airworthiness Directives; Bell Helicopter Textron Canada Helicopters**

**ACTION:** Notice of proposed rulemaking (NPRM).

#### **Bell Helicopter Textron Canada (BHTC):**

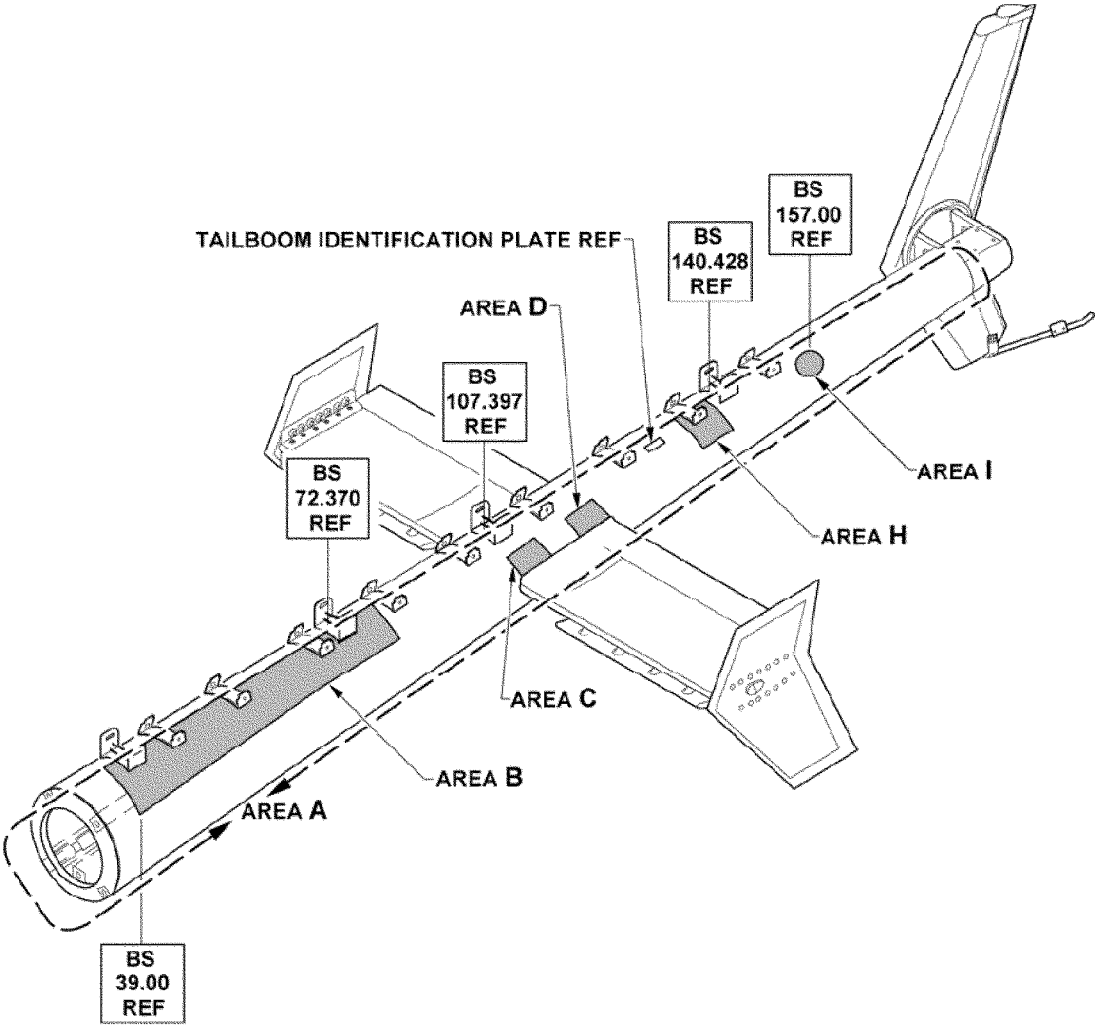
Figure 1 to Paragraph (d)

This AD defines the unsafe condition as high-stress-concentration areas in the tailboom skin that are at risk of cracking. This condition could result in a crack in the tailboom assembly, failure of the tailboom, and subsequent loss of helicopter control.

(A) Before the first flight of each day, visually check for a crack in the “C” and “D” areas depicted in Figures 1 and 2 to Paragraph (d) of this AD. The actions required by this paragraph may be performed by the owner/operator (pilot) holding at least a private pilot certificate, and must be entered into the aircraft records showing compliance with this AD in accordance with 14 CFR 43.9 (a)(1)–(4) and 14 CFR 91.417(a)(2)(v). The record must be maintained as required by 14 CFR 91.417, 121.380, or 135.439; or

(5) If there is a crack in the tailboom assembly, before further flight, replace it with an airworthy tailboom assembly.

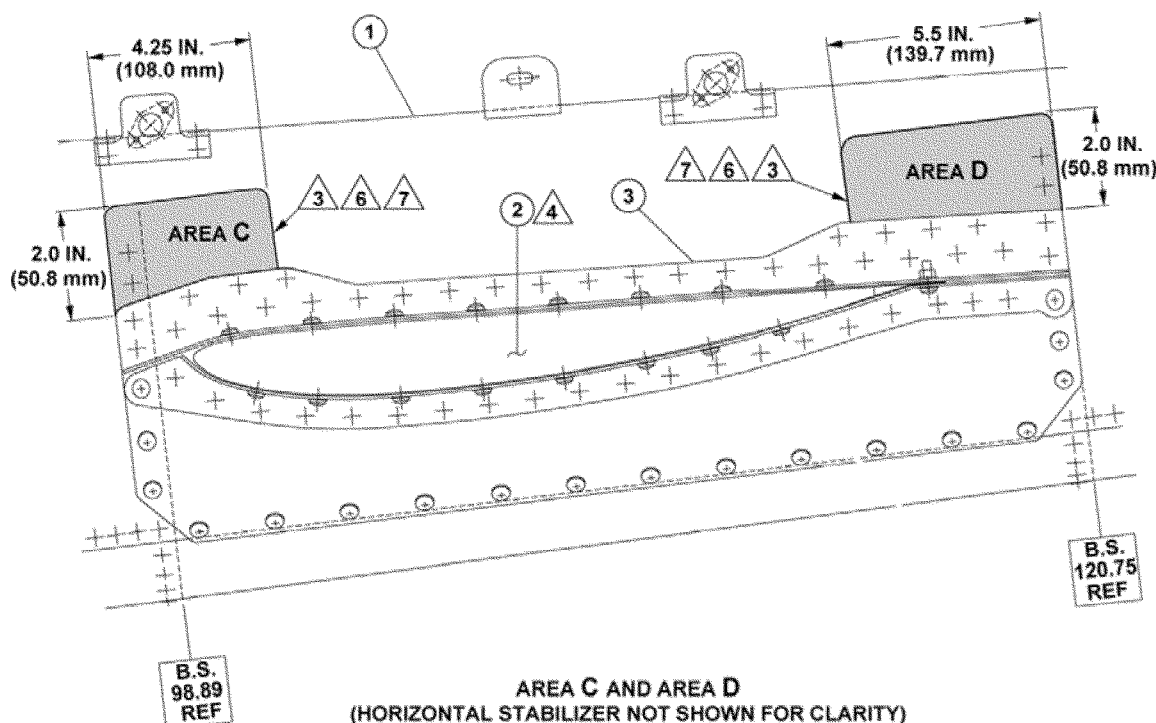
**Figure 2 to Paragraph (d)**

(B) Within 25 hours TIS, or 30 days, whichever comes first, and thereafter at intervals not to exceed 50 hours TIS, clean and inspect for a crack around each fastener and just above the edge of the upper stabilizer support in the "C" and "D" areas on the left side of the tailboom assembly, as depicted in Figure 2 to Paragraph (d) of this AD, using a 10X or higher power magnifying glass.
