[Docket No. FAA-2013-0574; Directorate Identifier 2008-SW-22-AD; Amendment 39-17766; AD 2014-04-07]

#### Airworthiness Directives; Bell Helicopter Textron Canada (Bell) Helicopters

#### 2014–04–07 Bell Helicopter Textron

This AD defines the unsafe condition as cracks in the tailboom skin on the left side in the area of horizontal stabilizer, which could result in separation of the tailboom and subsequent loss of control of the helicopter.

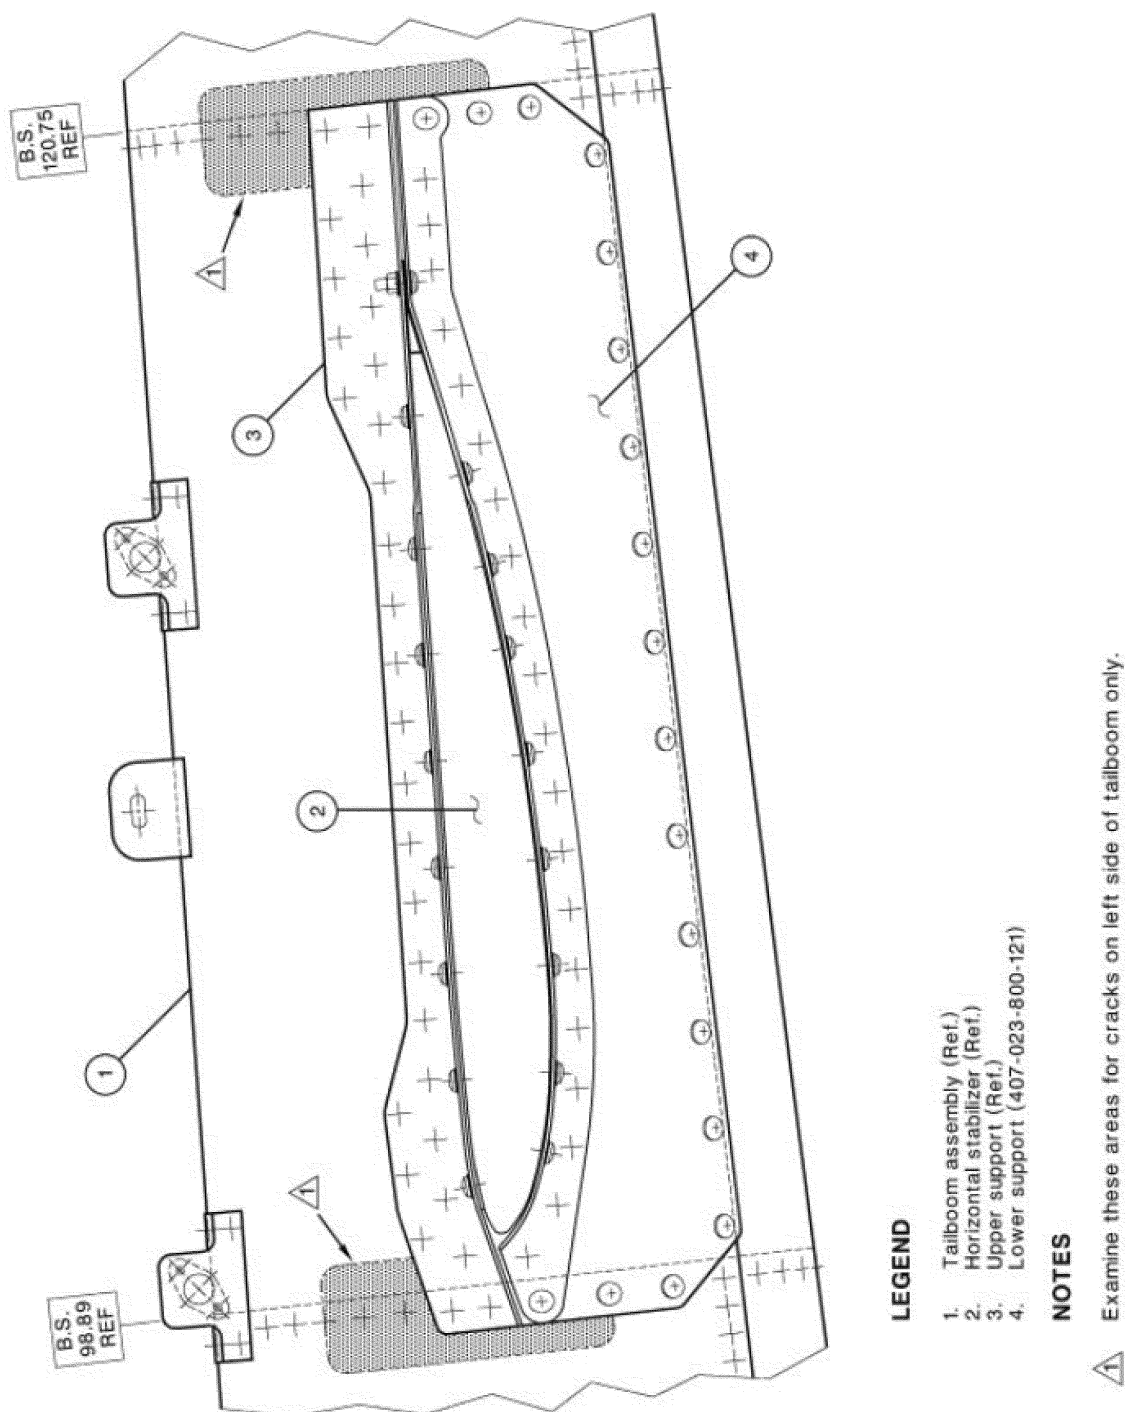
(A) Before the first flight of each day, visually check the tailboom for a crack, as depicted in Figure 1 to Paragraph (f)(1)(i)(A) of this AD.

(3) If there is a crack, before further flight, replace the tailboom.
