**[Docket No. FAA-2014-1083; Directorate Identifier 2014-CE-036-AD; Amendment 39-18140; AD 2015-08-04]**

#### **Airworthiness Directives; Various Aircraft Equipped With Wing Lift Struts**

**ACTION:** Final rule.

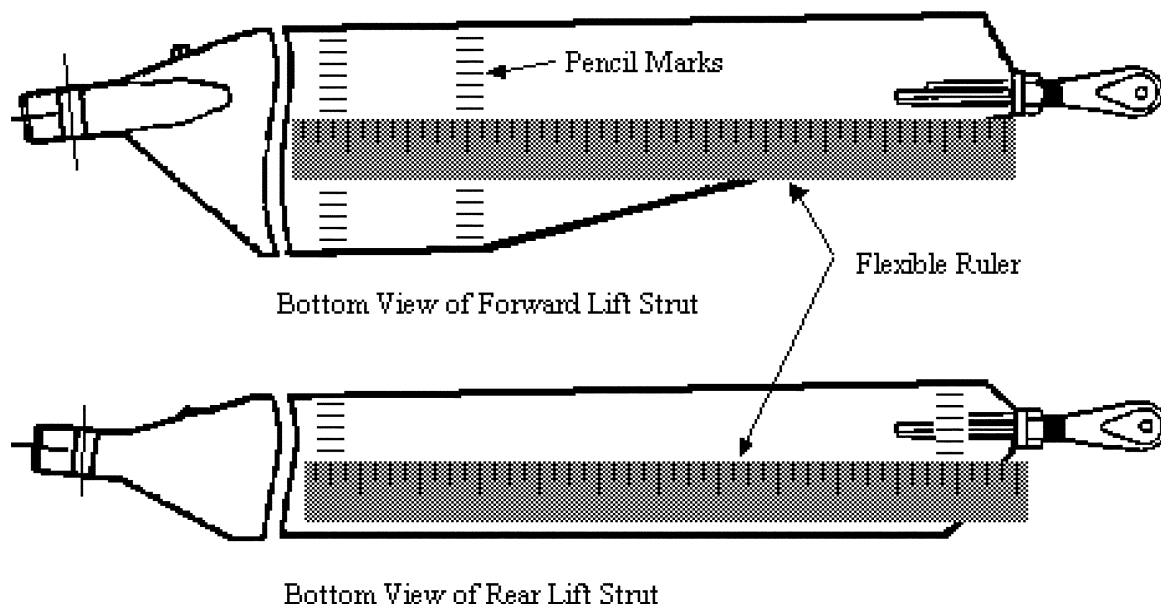
Figure 1

8. A measurement of 0.024-inch or less shall require replacement of the strut prior to further flight.
