[Docket No. FAA-2016-6651; Directorate Identifier 2016-SW-015-AD; Amendment 39-18867; AD 2017-09-05]

Airworthiness Directives; Airbus Helicopters

SUMMARY: We are adopting a new airworthiness directive (AD) for Airbus Helicopters Model AS332C, AS332C1, AS332L, AS332L1, AS332L2, and EC225LP helicopters. This AD requires repetitively checking screws in the emergency flotation gear. This AD is prompted by a report that a screw ruptured on a Model AS332 helicopter's emergency flotation gear. These actions are intended to correct an unsafe condition on these products.

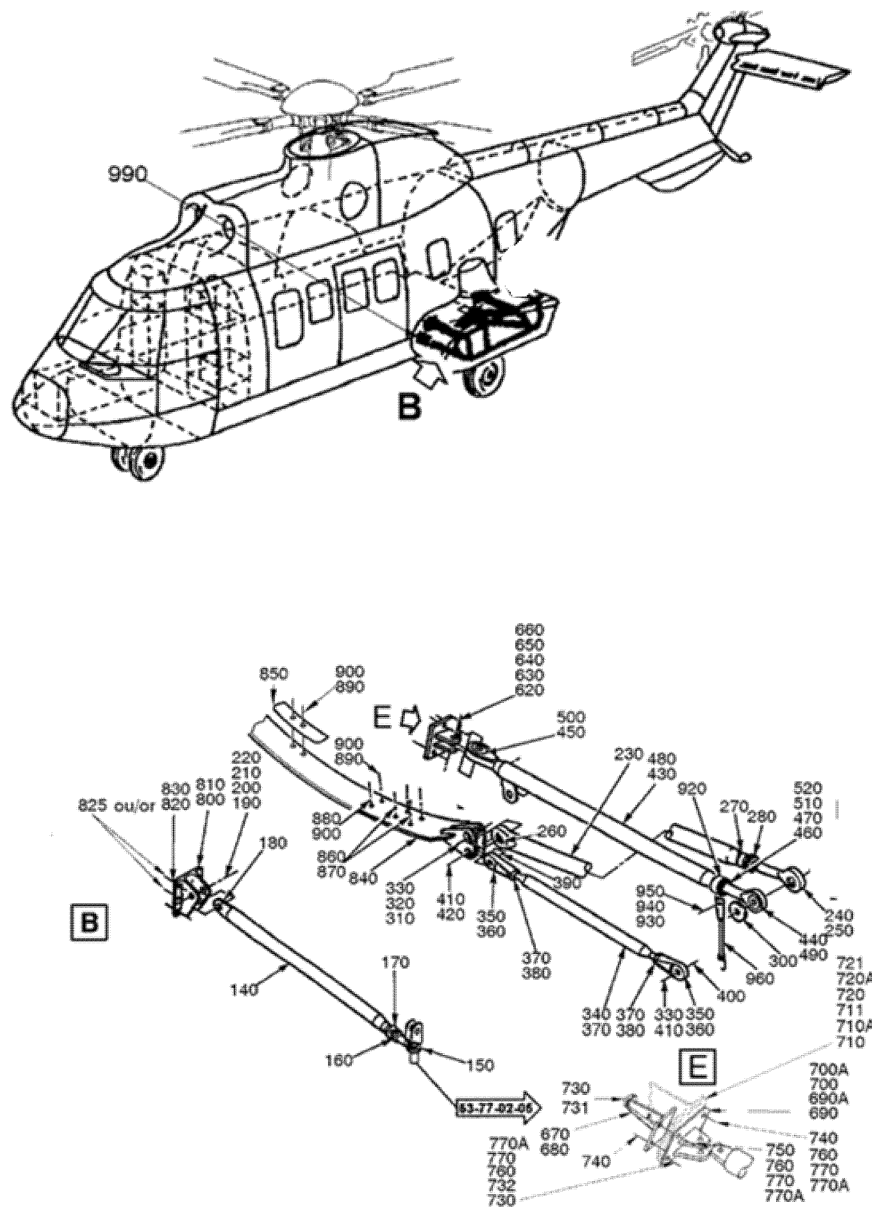
Figure 1 to Paragraph (e)(1) of this AD

This AD defines the unsafe condition as failure of a rear upper screw fitting on the emergency flotation gear. This condition, if not detected and corrected, could result in failure of the emergency flotation system and subsequent capsizing of the helicopter.

(1) Visually check each emergency flotation gear left hand and right hand rear upper fitting to determine whether the heads of the lower screws are present. Figure 1 to paragraph (e)(1) of this AD depicts where the lower three screws (noted as B and E) are located. Check each screw for looseness by

(2) If a screw head is missing or if a screw is loose, before further flight over water, replace all screws in the fitting. Replacing the screws is not a terminating action for the repetitive checks required by this AD.
