## DEPARTMENT OF TRANSPORTATION

### Federal Aviation Administration

[Docket No. FAA-2016-9254; Directorate Identifier 2015-CE-030-AD; Amendment 39-18948; AD 2017-14-04]

#### Airworthiness Directives; Piper Aircraft, Inc. Airplanes

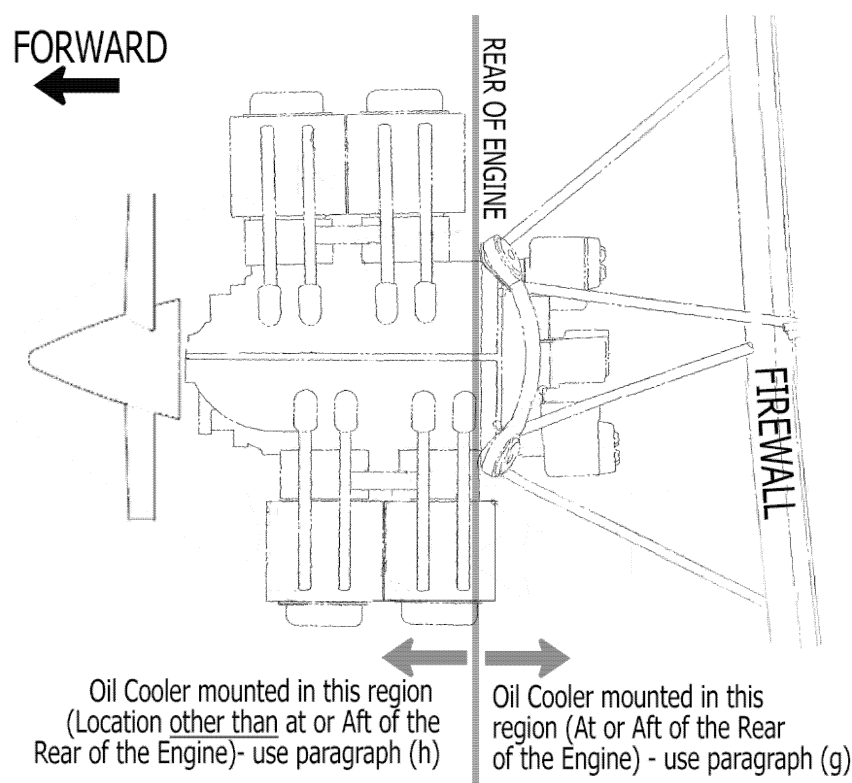
Figure 1 to paragraphs (g) and (h) of this AD: Oil cooler

*For any oil cooler hose assemblies that do not meet TSO–C53a, Type D requirements:* Within the next 100 hours time-in-service (TIS) after February 5, 1996 (the effective date retained from AD 95–26–13), and repetitively thereafter at intervals not to exceed 100 hours TIS, inspect the fire sleeve of each oil cooler hose assembly for soaked oil, a brownish or whitish color, and any evidence of brittleness or deterioration as a result of heat or oil seepage. See figure 1 to paragraphs (g) and (h) of this AD for additional information.

after February 5, 1996 (the effective date retained from AD 95-26-13), and repetitively thereafter at intervals not to exceed 100 hours TIS, inspect the fire sleeve of each oil cooler hose assembly for soaked oil, a brownish or whitish color, and any evidence of brittleness or deterioration as a result of heat or oil seepage. See figure 1 to paragraphs (g) and (h) of this AD for additional information.

(1) If any of the conditions described in paragraph (g) or (h)(1) of this AD are found on an oil cooler hose assembly during the inspection required in paragraph (g) or (h)(1) of this AD, as applicable, before further flight, replace the oil cooler hose assembly with a serviceable new or used TSO-C53a Type D oil cooler hose assembly or TSO-C53a Type C oil cooler hose assembly. If a used TSO-C53a Type C oil cooler hose assembly is installed, it must have documented hours TIS.

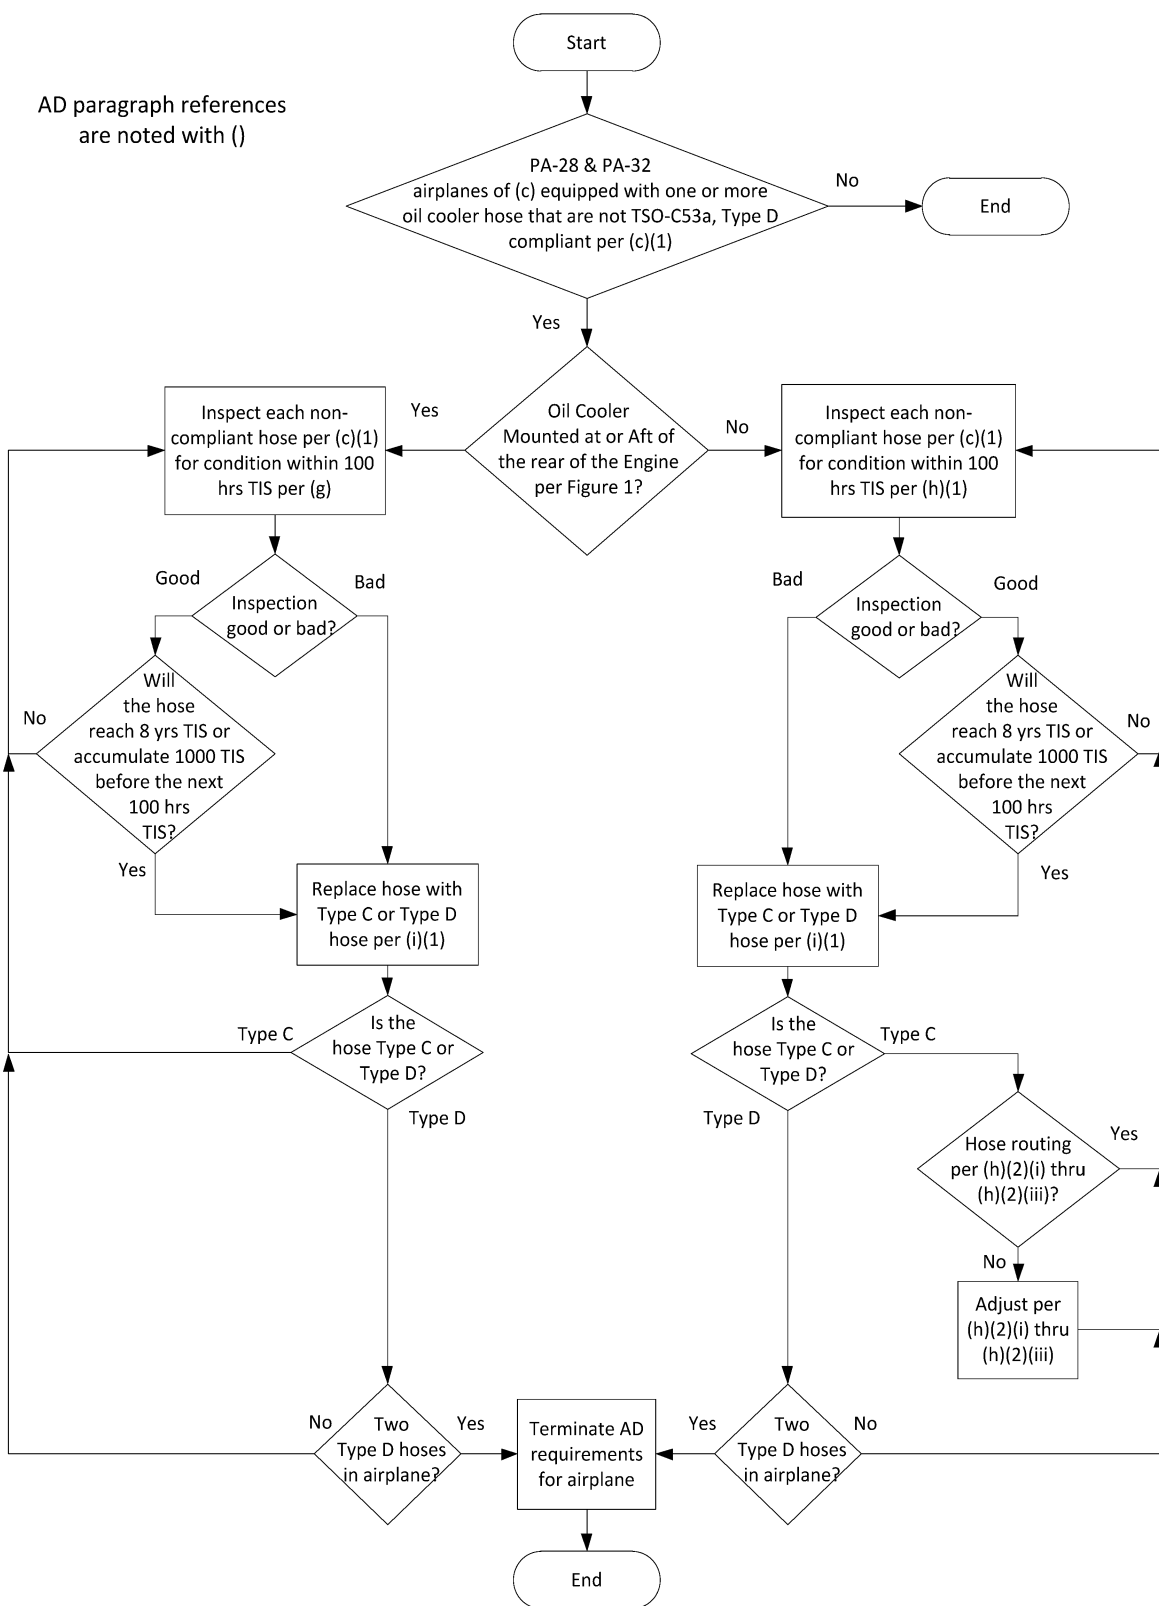
## Appendix 1 to AD 2017-14-04

Comply with this AD within the compliance times specified, unless already done. You may review the flow chart found in appendix 1 to assist you in complying with the actions of this AD.
