## DEPARTMENT OF TRANSPORTATION

### Federal Railroad Administration

#### Addressing Electrode-Induced Rail Pitting From Pressure Electric Welding

**ACTION:** Notice of draft Safety Advisory; request for comment.

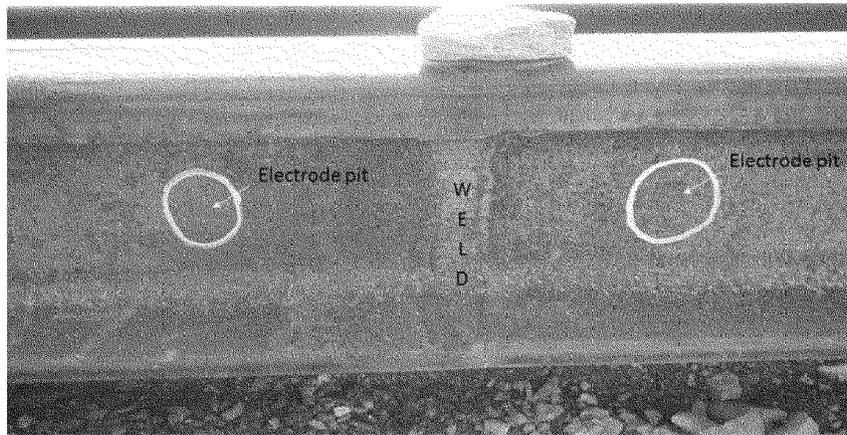
as stress raisers (also referred to as stress concentrations). Fatigue cracks often develop at locations of stress concentration. Once a fatigue crack initiates, the localized stress encourages the growth of the crack, which may potentially lead to rail failure. FRA believes electrode pitting may be a contributing factor, if not the root cause, in some accidents involving rail web cracking.

Figure 1 below shows a photograph of a rail with electrode pits in the web. The location of these electrode pits, when they occur, is typically four to eight inches on either side of the weld. Electrode-induced pitting from pressure electric welding may also occur in the head and base of the rail. At this time, it is unclear whether traditional ultrasonic rail testing can consistently detect electrode-induced pitting.

Figure 1: Electrode-Induced Pits in a Rail

a. Removing the section of rail containing electrode-induced pitting and re-welding the rail; or

b. Developing and applying possible alternative methods to remove electrode-induced pitting, such as drilling, if electrode-induced pitting is found and the section of rail cannot be readily removed or re-welded.

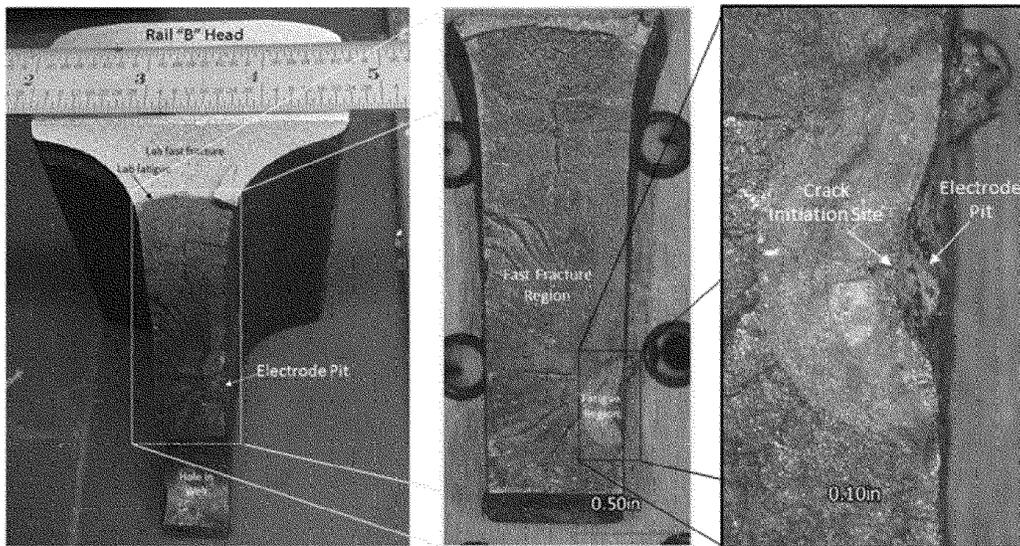
Specifically, Benét's metallurgical analyses concluded the cracking in the rail web originated from the pitting created by inadequate electrode-to-rail contact during the pressure electric welding process. The fractographic and metallographic examinations revealed evidence of fatigue cracking originating from the pitting and fast fracture once the fatigue crack reached a critical length. Figure 2 below shows three photographs of the fracture surface of a crack found in one of the rails Benét examined. These photographs support

the metallurgical evidence indicative of three stages of fatigue fracture: (1) Crack initiation or formation originating from the pitting; (2) crack propagation or growth by metal fatigue; and (3) final rupture or fast fracture. Figure 3 below shows photographs of the microstructure near the electrode pits in each examined rail, providing further evidence the cracking originated from the pitting created by improper electrode contact during welding.

Figure 2: Photographs of Crack Fracture Surface in Examined Rail

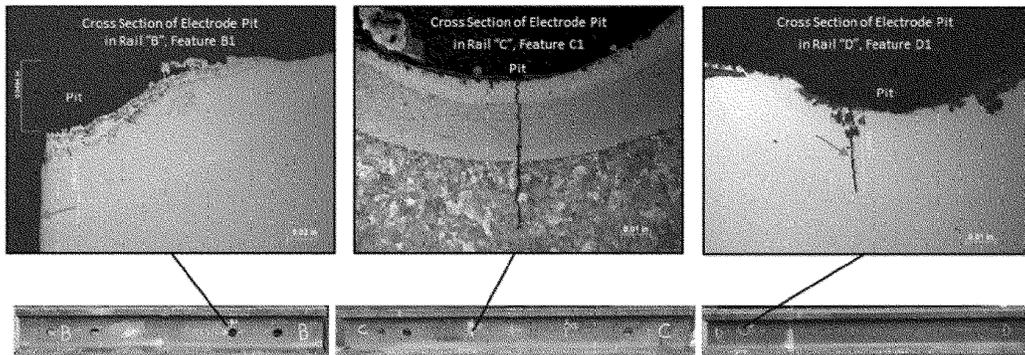
Figure 3: Photographs of Rail Cross Sections
