DEPARTMENT OF TRANSPORTATION

Federal Railroad Administration

[Docket No. FRA-2017-0074, Notice No. 2; Safety Advisory 2018-01]

Addressing Electrode-Induced Rail Pitting From Pressure Electric Welding

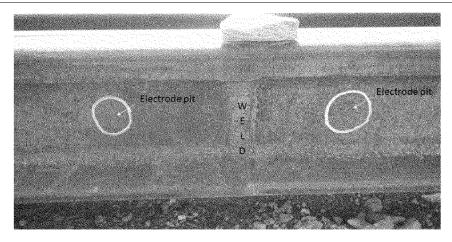
Figure 1 below shows a photograph of a rail with electrode pits in the web. The location of these electrode pits, when they occur, is typically four to eight inches on either side of the weld. Electrode-induced pitting from pressure electric welding may also occur in the head and base of the rail. It is unclear whether traditional ultrasonic rail

Figure 1: Electrode-Induced Pits in a Rail

railroad employees, railroad contractors, and welding companies and their employees of the importance of complying with those procedures to prevent electrode pitting and, ultimately, to prevent rail failures. (FRA has posted a copy of this notice on its public website, www.fra.dot.gov, where you may view the figures below in their full resolution.)

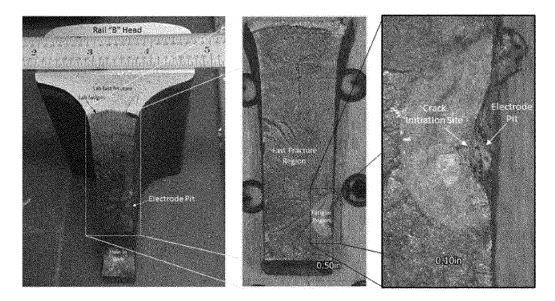
Specifically, Benét's metallurgical analyses concluded the cracking in the rail web originated from the pitting created by inadequate electrode-to-rail contact during the pressure electric welding process. The fractographic and metallographic examinations revealed evidence of fatigue cracking originating from the pitting and fast fracture once the fatigue crack reached a critical length. Figure 2 below shows three photographs of the fracture surface of a crack found in one of the rails Benét examined. These photographs support the metallurgical evidence indicative of three stages of fatigue fracture: (1) Crack initiation or formation originating from the pitting; (2) crack propagation or growth by metal fatigue; and (3) final rupture or fast fracture. Figure 3 below shows photographs of the microstructure near the electrode pits in each examined rail, providing further evidence the cracking originated from the pitting created by improper electrode contact during welding.

Figure 2: Photographs of Crack Fracture Surface in Examined Rail

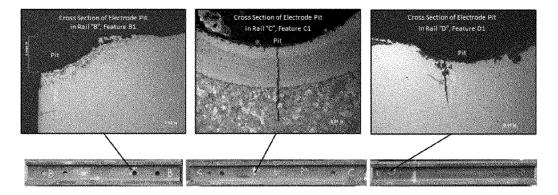
chromium, which were still within AREMA tolerances. Testing of the chemistry and the mechanical properties revealed all three rails were made from standard quality steel containing no other defects except the electrode-induced pitting.

Figure 3: Photographs of Rail Cross Sections
