[Docket No. 99-SW-34-AD]

Airworthiness Directives; Eurocopter France Model SA-365N1, AS-365N2, and SA-366G1 Helicopters

ACTION: Notice of proposed rulemaking.

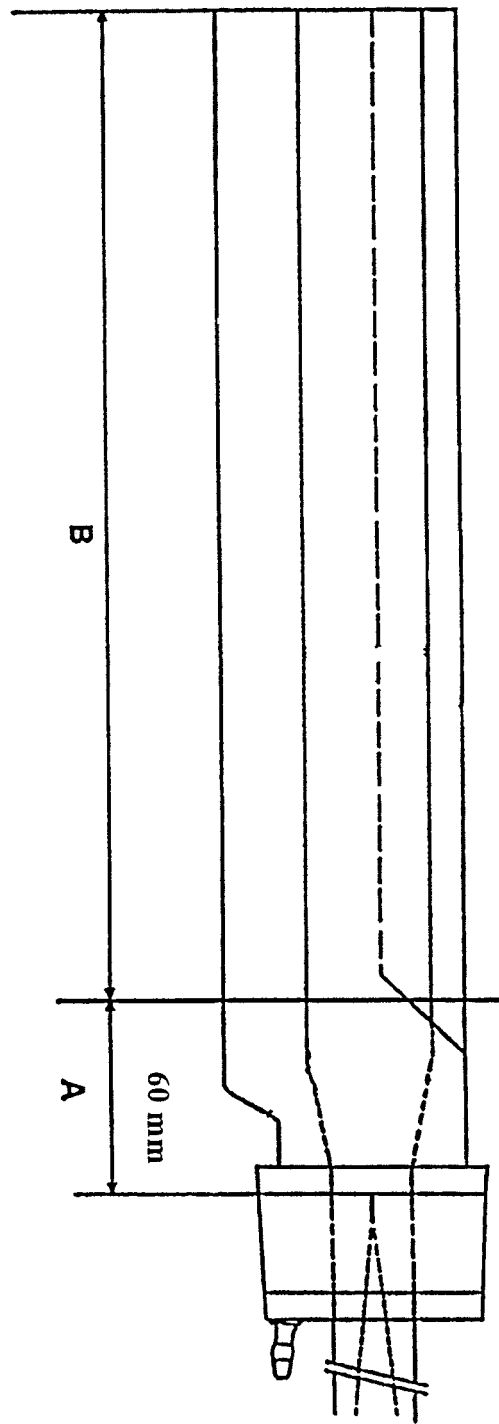
FIGURE 1

(a) Within 10 hours time-in-service (TIS) and thereafter before the first flight of each day, visually check each blade (see Figure 1) for a crack, blister, or wrinkling. An owner/operator (pilot), holding at least a private pilot certificate, may perform the visual check and must enter compliance into the aircraft maintenance records in accordance with 14 CFR sections 43.11 and 91.417(a)(2)(v).

(b) If a crack, blister, or wrinkling is found as a result of the visual check, accomplish the following before further flight (see Figure 1):

(1) Zone A: If a blister is detected on the blade suction face, conduct a tapping test inspection on the whole blade for bonding separation.

(2) Zone B: If a crack, wrinkling, or a blister is found, replace the blade with an airworthy blade before further flight.

(i) For blades, P/N 365A33-2131-all dash numbers, 365A12-0010-all dash numbers, and 365A12-0020-00, and -01, if bonding separation or a crack is found, replace the blade with an airworthy blade before further flight.

(ii) For blades, P/N 365A12-0020-02, and -03, if bonding separation exceeds 900 mm² in a 30 x 30 mm square or if there is a crack, replace the blade with an airworthy blade before further flight.
