[Docket No. 2001-NE-03-AD; Amendment 39-12097; AD 2001-02-12]

#### **Airworthiness Directives; CFM International (CFMI) Model CFM56-7B Turbofan Engines**

#### 2001-02-12 CFM International:

Amendment 39-12097. Docket No. 2001-NE-03-AD.

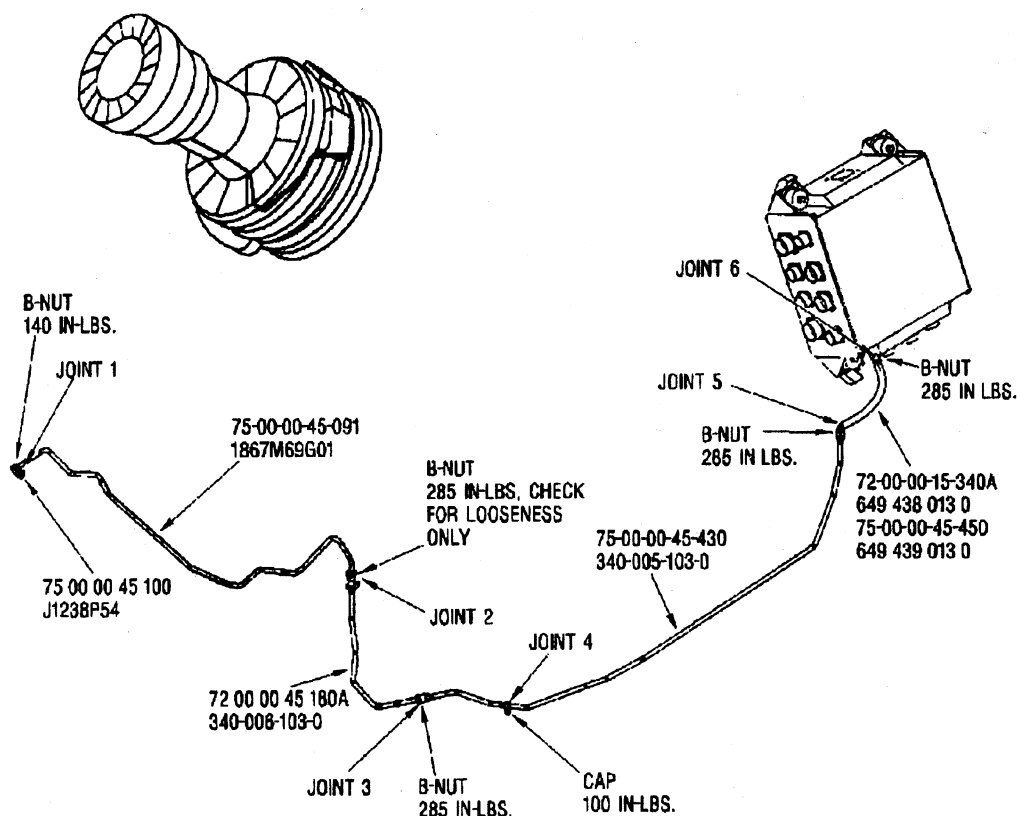
**SUPPLEMENTARY INFORMATION:** The FAA has received reports of two in-flight shutdowns and one aborted take-off on three different Boeing 737NG airplanes powered by CFM56-7B turbofan engines. In all of these cases, the engine rolled back to idle speed and would not accelerate. The investigation revealed that the PS3 pressure line B-nut fitting at the 6 o'clock position had disconnected in two of these events and the PS3 pressure B-nut fitting at the combustion case port location had disconnected in the third event. An operator, involved in one of the IFSD events, completed on-wing torque inspections of the PS3 pressure line fittings of its CFMI CFM56-7B fleet. As a result of these inspections, one engine was found with a loose B-nut fitting at the 6 o'clock location and two engines were found with loose cap fittings at the 6 o'clock location. The two engines with loose caps were on the same airplane. The investigation also initiated PS3 pressure line fitting torque inspections on 10 engines that were on Boeing's flight line. These inspections revealed one engine with a loose B-nut fitting at the 6 o'clock position and one engine with a loose cap fitting at the 6 o'clock position. General Electric and SNECMA also inspected CFM56-7B engines that were in assembly. No loose fittings were found. The investigation to determine the cause of the loose PS3 pressure line fittings continues. Action to insure correct torque of these fittings on current production engines has been initiated by adding a new torque inspection requirement for the PS3 pressure line fittings at the end of the main engine assembly process. However, based on the inspection results indicated above, it has been determined that mandating action on in-service engines to ensure that the PS3 pressure line fittings are correctly torqued is required.

To prevent air leakage from incorrectly torqued fittings of the PS3 pressure line, which could result in engine power loss, do the following:

(a) Check for and apply the correct torque in the tightening direction of all PS3 pressure line fittings as identified in Figure 1 of this AD as Joint 1, Joint 2, Joint 3, Joint 4, Joint 5, and Joint 6 as follows:

(1) Torque Joint 1 to ensure a torque value of 140 inch-pounds.

(2) Due to accessibility limitations, check Joint 2 for finger looseness, and only if loose, torque to a value of 285 inch-pounds.

(3) Torque Joint 3, Joint 5, and Joint 6 to ensure a torque value of 285 inch-pounds.

(4) Torque Joint 4 to ensure a torque value of 100 inch-pounds.
