**Airworthiness Directives; Boeing Model 707 Airplanes and Model 720 and 720B Series Airplanes**

**2007-23-12 Boeing:** Amendment 39-15258. Docket No. FAA-2007-28828; Directorate Identifier 2007-NM-010-AD.

## Appendix 1. 707 SFAR 88 Survey Areas

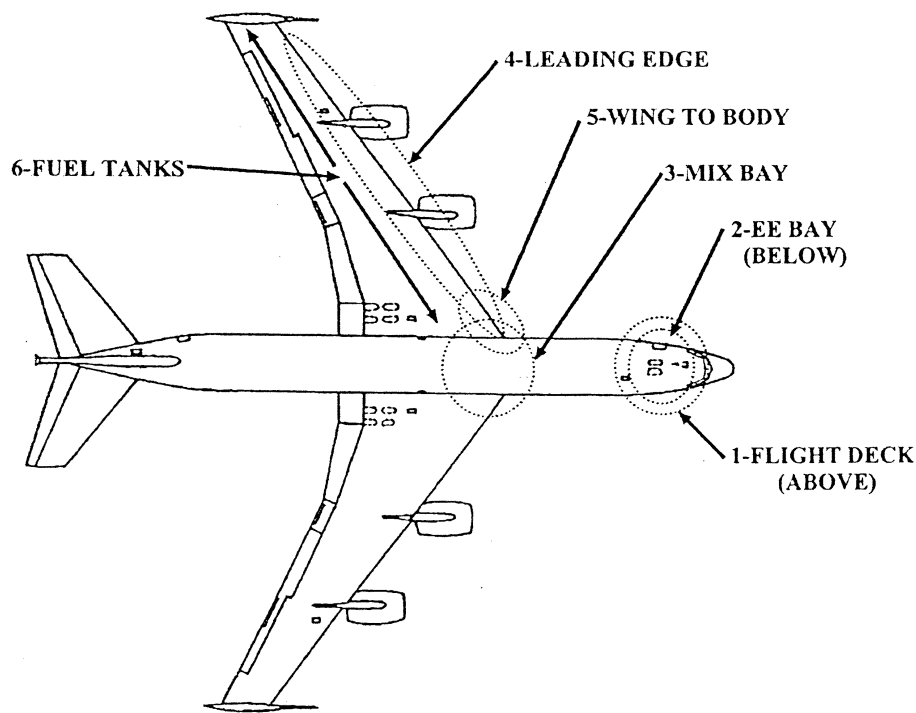
707 SFAR 88 SURVEY  
AREAS

**1) Flight Deck**

New circuit breakers will be installed on the P1, P2, P3, P4 and/or P5 panels. Two new indication lights are installed in the lower P11 panel. Provide photographs of these panels.

Provide photos of the Flight Deck area above and below the Engineer's panel and on the opposite side showing the existing wire bundle routing with the ceiling and side panels removed. This will be used to route additional wire bundles separated from the existing power wires that will be routed to the EE Bay.

Verify the part number(s) of the FQIS indicators installed in the P11 panel. Verify if a remote trimmer is installed for this indicator.

### 2) E/E-Bay

Provide photos of any location within the E/E-Bay where there is enough space to install a J-box. A J-box is a 22 inch by 12 inch by 4.0 inch tall avionics box that contains control relays. A new J-box must be installed in order to add the Ground Fault Interrupt relays and the Pump Un-commanded ON relays. Possible locations are along the body structure and beneath the cabin floor.

### 3) Mix Bay

Provide photos showing the tubing and duct routing from the wing section. Provide photos of the current wire bundles in the mix bay. Boeing intends to add 18 new splices for the FQIS wire harness. Provide photos for the installation of a box which is 9 x 6 x 6 inches tall which may be required for FQIS Center Tank Hot Short Protection. Boeing requests photos from both inside the aircraft fuselage showing the wire routing and pressure vessel penetration.

### 4) Leading Edge

Provide photos of the Fuel Quantity Indication system connectors on the front for all fuel tanks. Provide photographs of the front spar every 3 feet from the reserve tank to the center tank. Photos should show tubing installations, existing wire harnesses, pneumatic ducts, etc. Photograph areas between the engine struts, outboard of engine 1 and 4, and between the inboard strut and side of body with a free 9 X 3 X 5 inch accessible areas. These photos will help Boeing engineering develop new FQIS wire routing that has a minimum of 2 inch separation from existing wires, or possibly to install new FQIS spar penetration connectors. Provide photos of the front spar and seal ribs with in the strut area with the access panels removed. These photos will also be used in the development of the FQIS wire shielding and separation.

### 5) Wing to Body (Un-pressurized wire penetrations)

Photos of the existing wire bundle penetrations through the pressure vessel and a 3 foot radius area around the existing wire bundle penetrations in the wing to body fairing (view from the front spar looking inboard).

### 6) Fuel Tanks

Provide photographs of the fuel quantity indication probes and the wiring for the probes. Photograph along the wiring to the spar penetration. Provide photographs of the internal tank structure and plumbing. Note that non-explosion proof equipment is generally not allowed inside fuel tanks.
