This procedure is to be used to detect cracks in the inner and outer spars of the front and rear spar assemblies of Raytheon Aircraft Company Beech Models 45 (YT-34), A45 (T-34A, B-45), and D45 (T-34B) airplane stabilizers outside of the steel bushings in the attach holes.

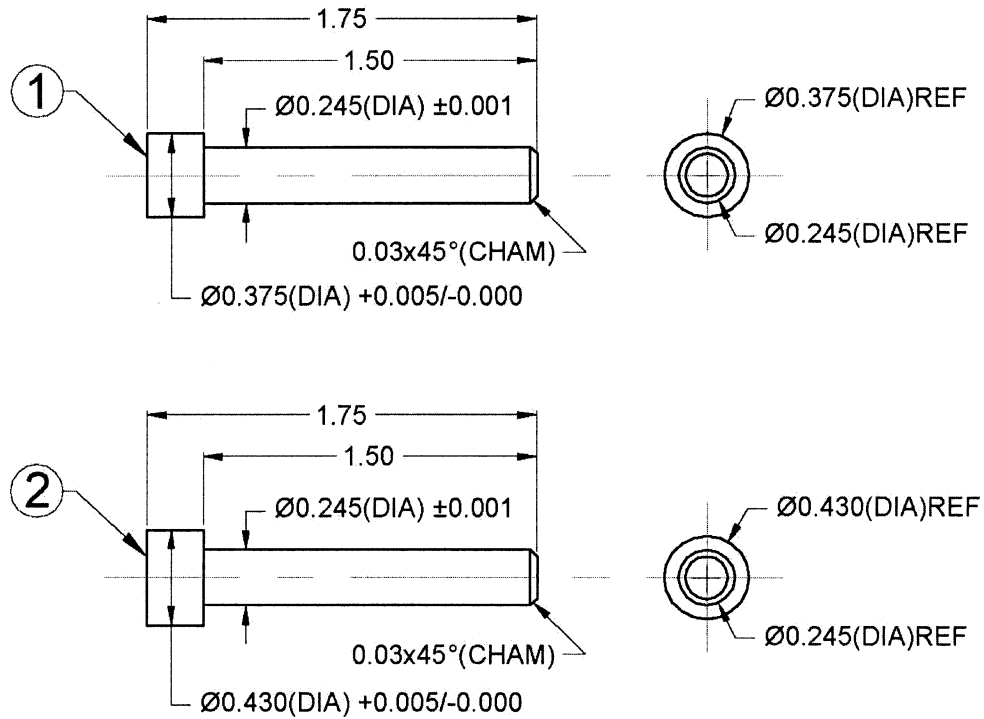
2	45-127-2	BUSHING TOOL	Ø0.44(DIA) x1.75	ALUMINUM		BREAK ALL SHARP EDGES
1	45-127-1	BUSHING TOOL	Ø0.38(DIA) x1.75	ALUMINUM		BREAK ALL SHARP EDGES
KEY	PART NO.	DESCRIPTION	SIZE	MATERIAL SPEC.	HEAT TREAT	NOTES
DIMENSIONING AND TOLERANCING IN INCHES UNLESS OTHERWISE SPECIFIED			CAD GENERATED DRAWING. DO NOT MANUALLY UPDATE		GENERAL AVIATION MODIFICATIONS, INC. 2800 AIRPORT ROAD, HANGAR A ADA, OKLAHOMA 74820	
ANGLES ± 2° DECIMALS .XX ± .01 DECIMALS .XXX ± .005 RIVET & BOLT EDGE MARGIN ± .05 BEND RADII ± .01 ON .03 & .05 ± .03 ON .09 & GREATER FRACTIONS ± 1/16 SURFACE ROUGHNESS 63RMS OR BETTER DIMENSIONS AND SURFACE TEXTURE DESIGNATIONS APPLY BEFORE PLATING OR FINISH COATING UNLESS OTHERWISE NOTED			APPROVALS	DATE	PROBE LOCATING, BUSHING TOOL	
			DRAWN LUKE KERR	3-14/05		
			CHECKED			
			RESP'ENG			
			MFG'ENG			
QUAL'ENG			SIZE DWG. NO.		REV	
			A 45-127		A	
			SCALE 1.5=1 CAD FILE 45-127 REVA.DWG		SHEET 1 OF 1

is flush with the edge of the bushing. Using the pin (see the attached Figures) as a guide, circle the area surrounding the steel bushing with the probe and adjacent area (approximately 1/4") to inspect for cracks. Inspect forward and aft surfaces surrounding bushings of each spar.
